NORTH SHORE WATERSHED STUDY

North Shore Watershed

Conservation Halton

March 2006

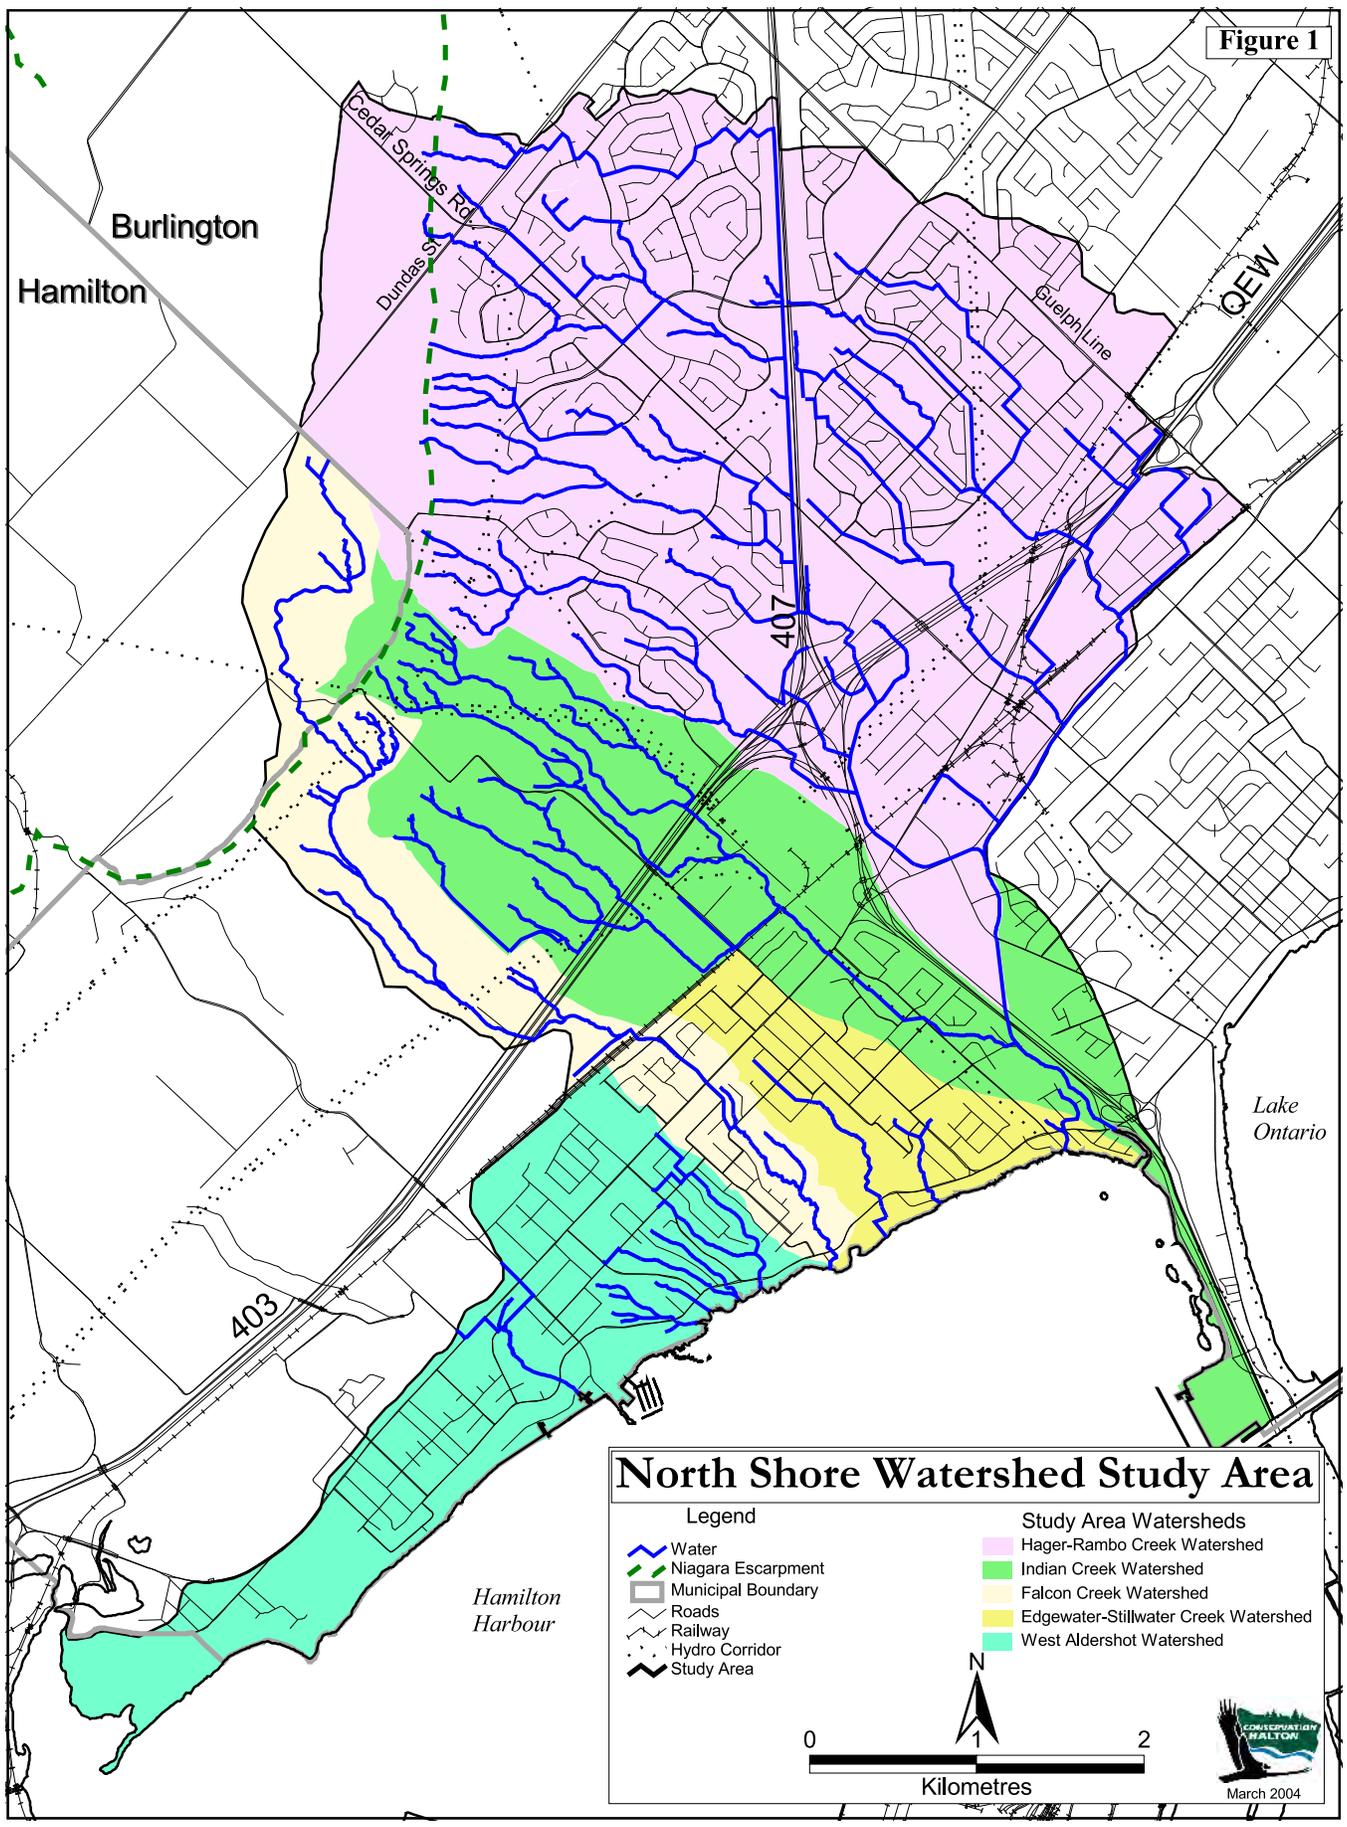
Figure 1

North Shore Watershed Study Area

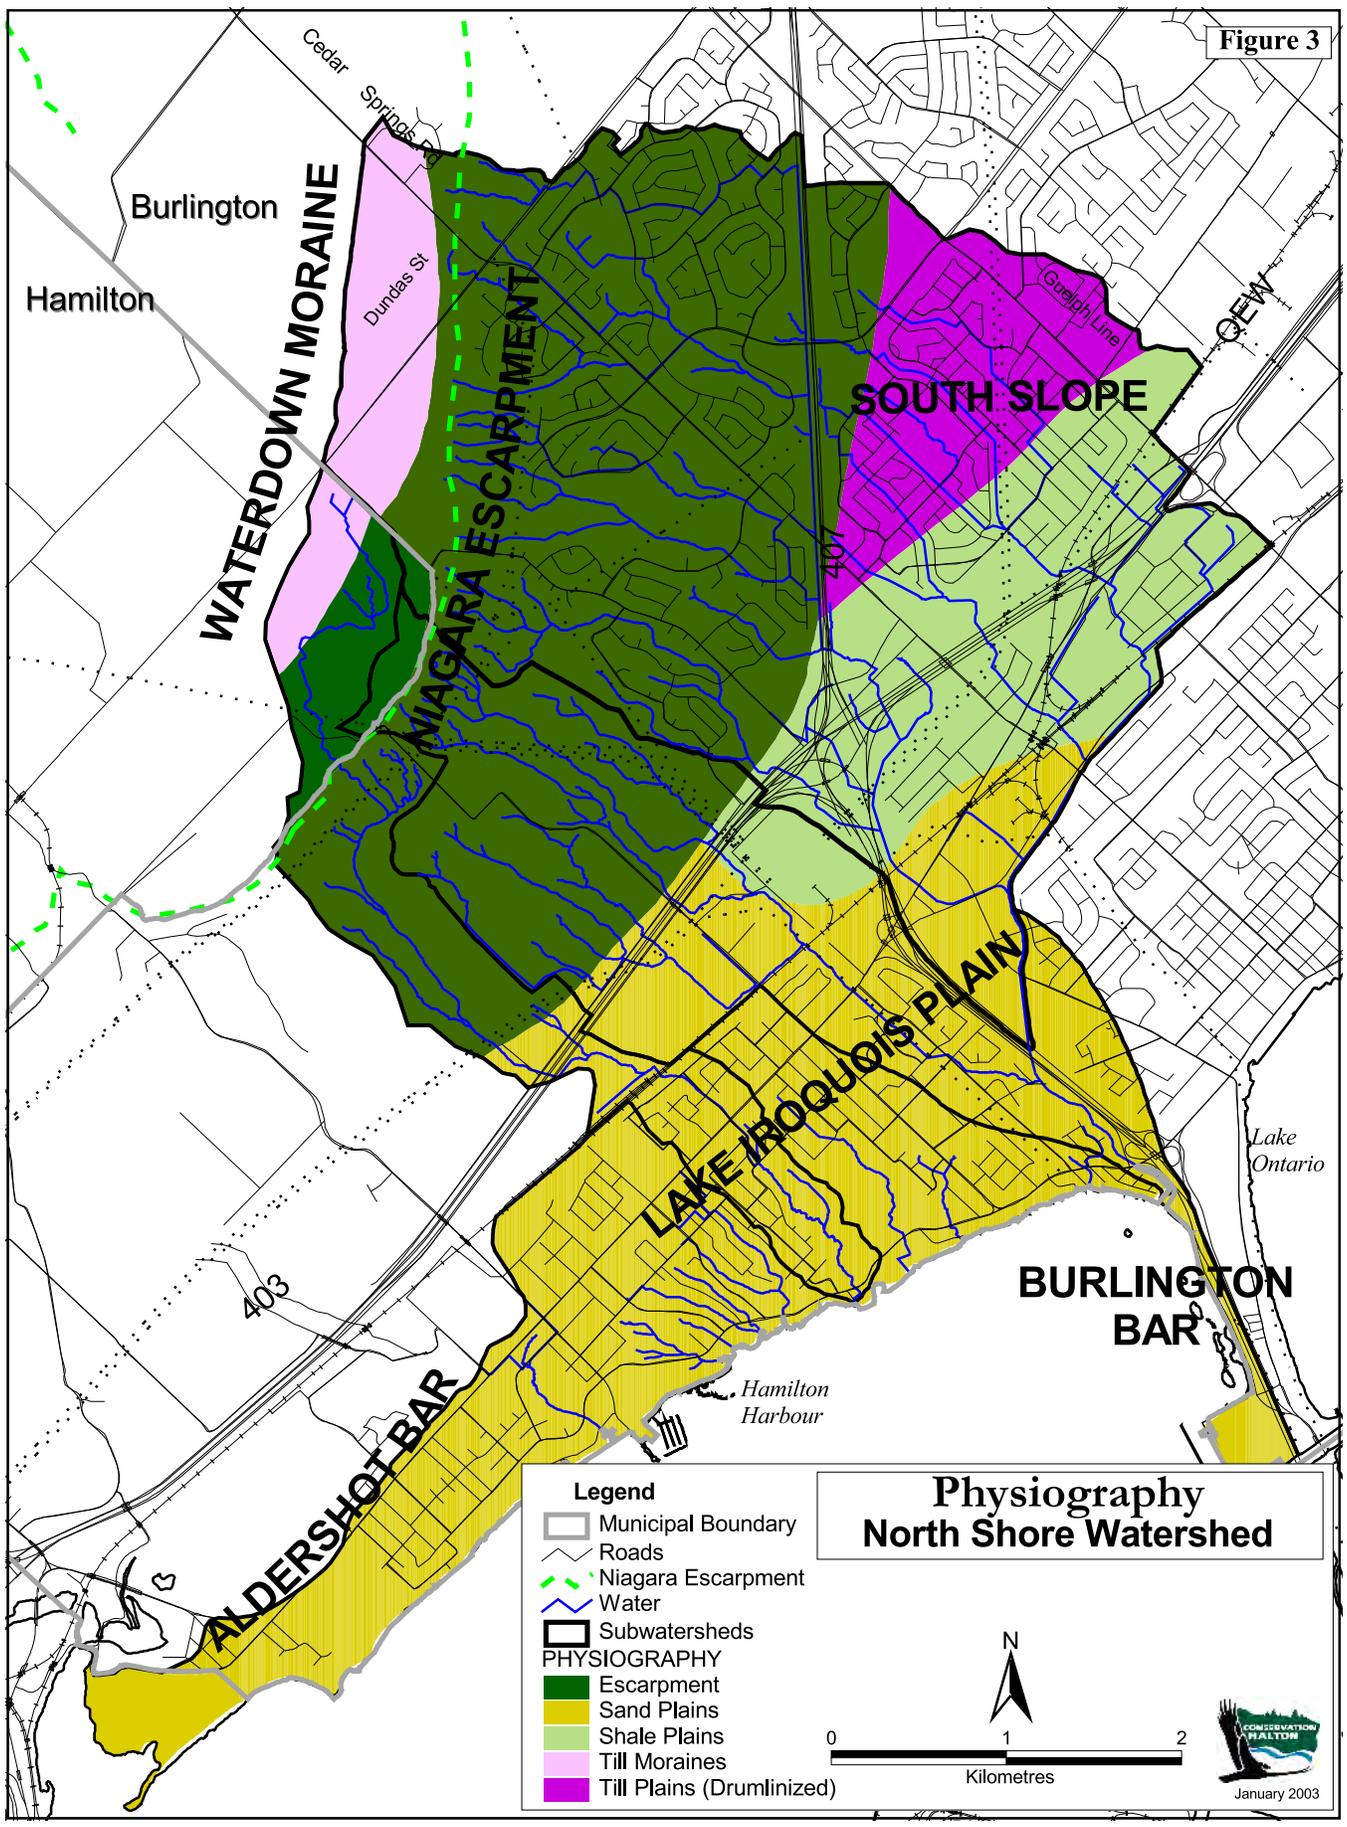
Figure 3

- Legend**
- Municipal Boundary
 - Roads
 - Niagara Escarpment
 - Water
 - Subwatersheds
- PHYSIOGRAPHY**
- Escarpment
 - Sand Plains
 - Shale Plains
 - Till Moraines
 - Till Plains (Drumlinized)

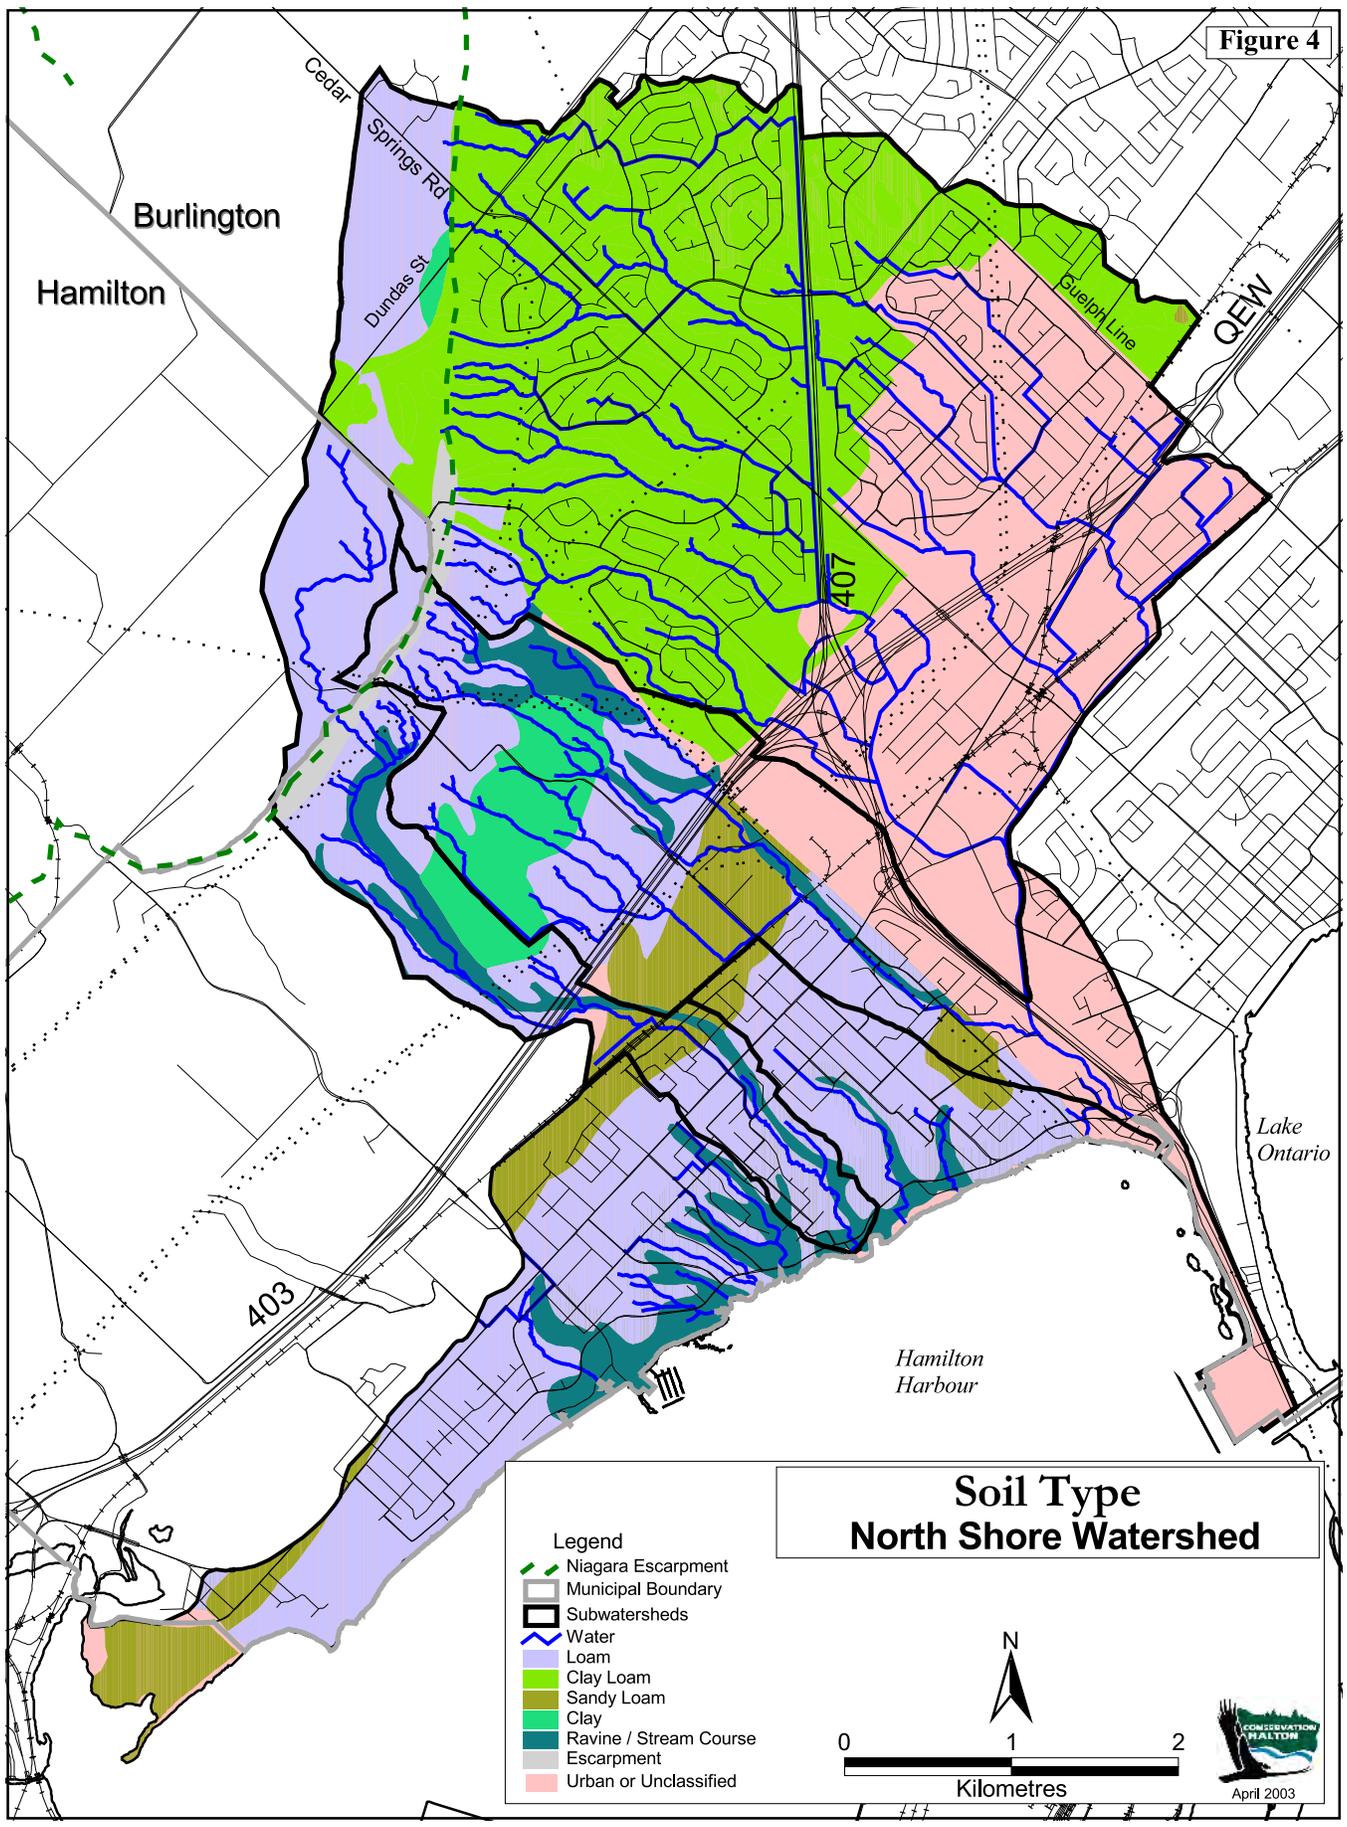
Figure 4

**Soil Type
North Shore Watershed**

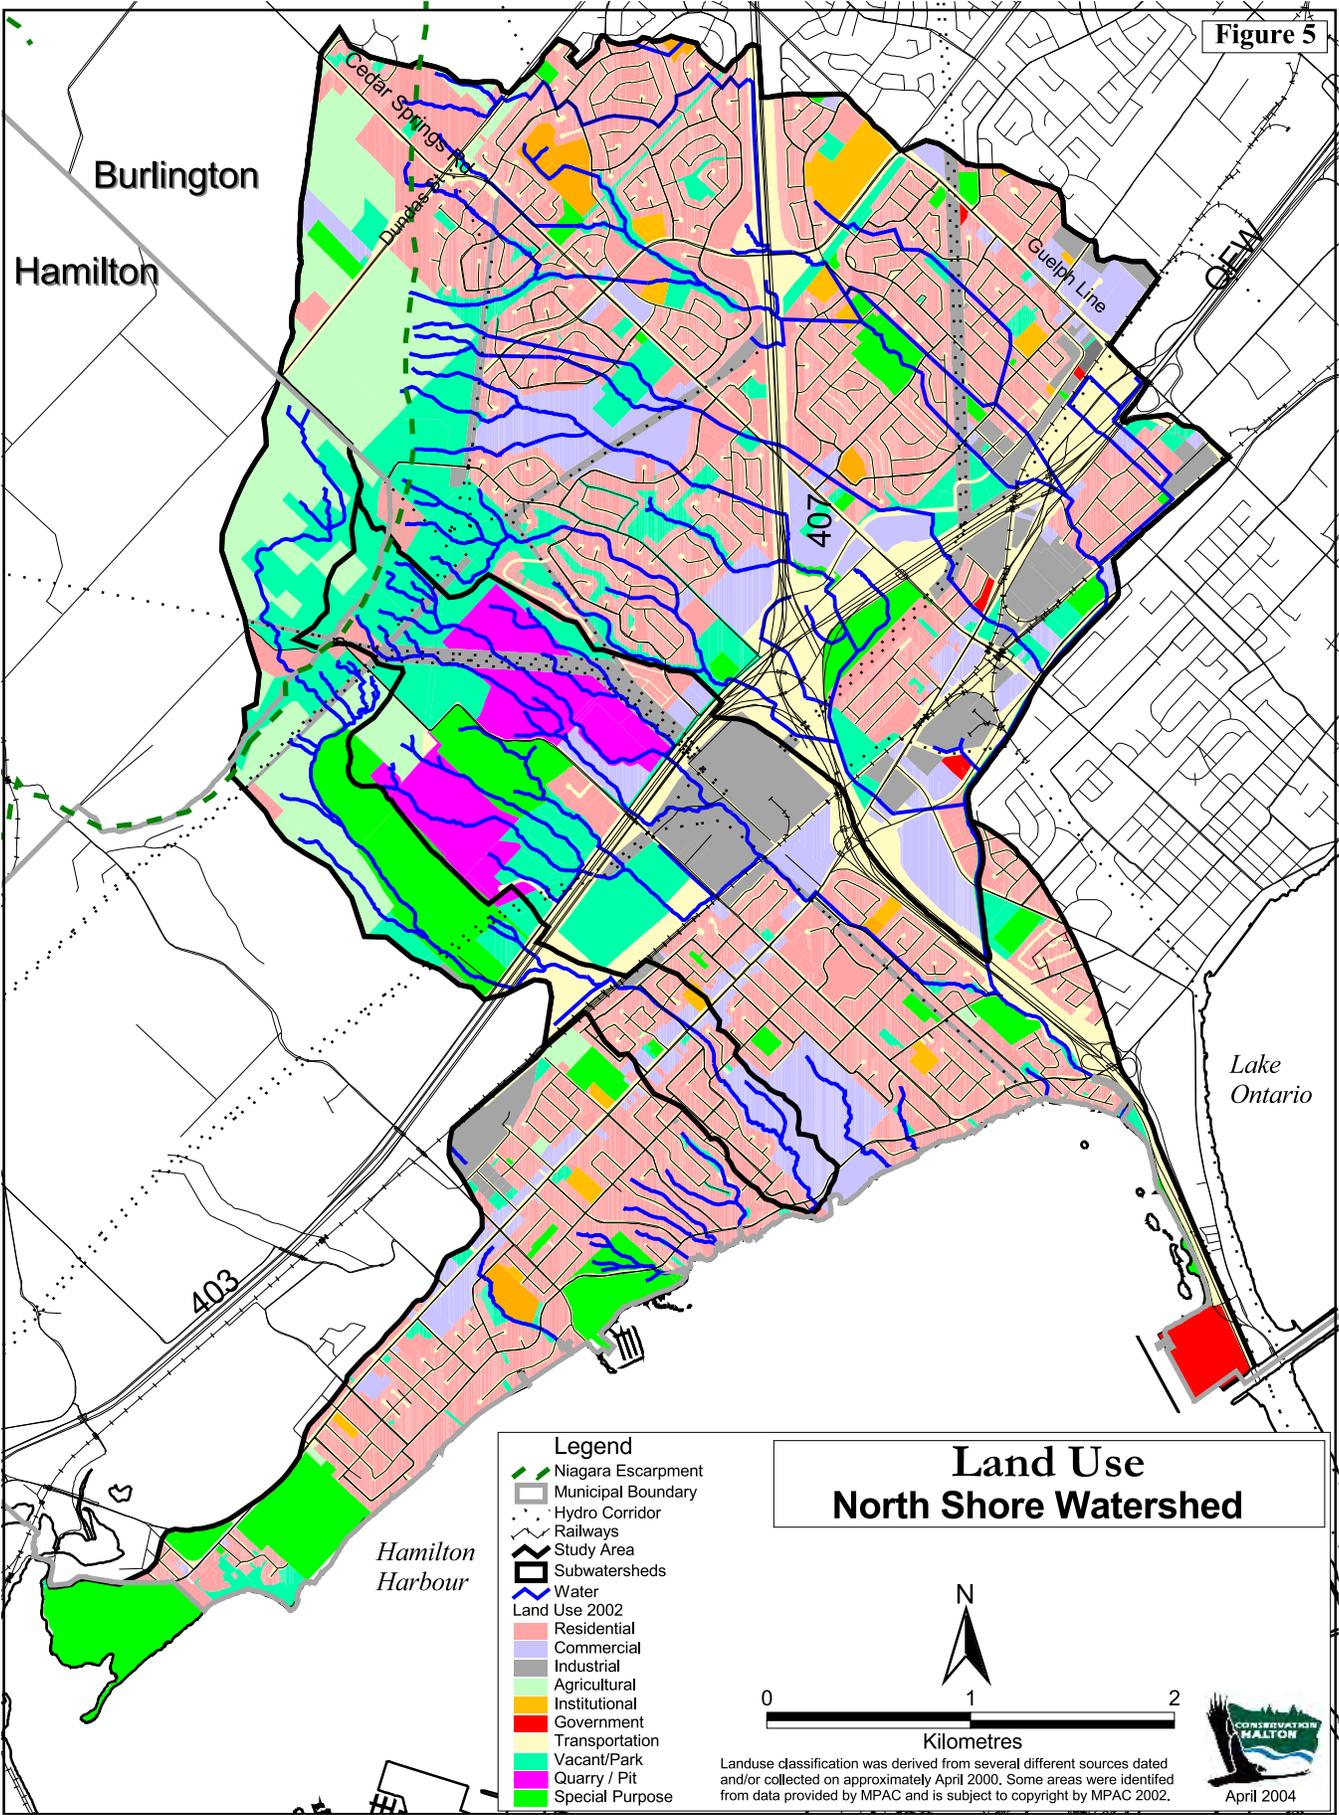
Figure 5

- Legend**
- Niagara Escarpment
 - Municipal Boundary
 - Hydro Corridor
 - Railways
 - Study Area
 - Subwatersheds
 - Water
 - Land Use 2002**
 - Residential
 - Commercial
 - Industrial
 - Agricultural
 - Institutional
 - Government
 - Transportation
 - Vacant/Park
 - Quarry / Pit
 - Special Purpose

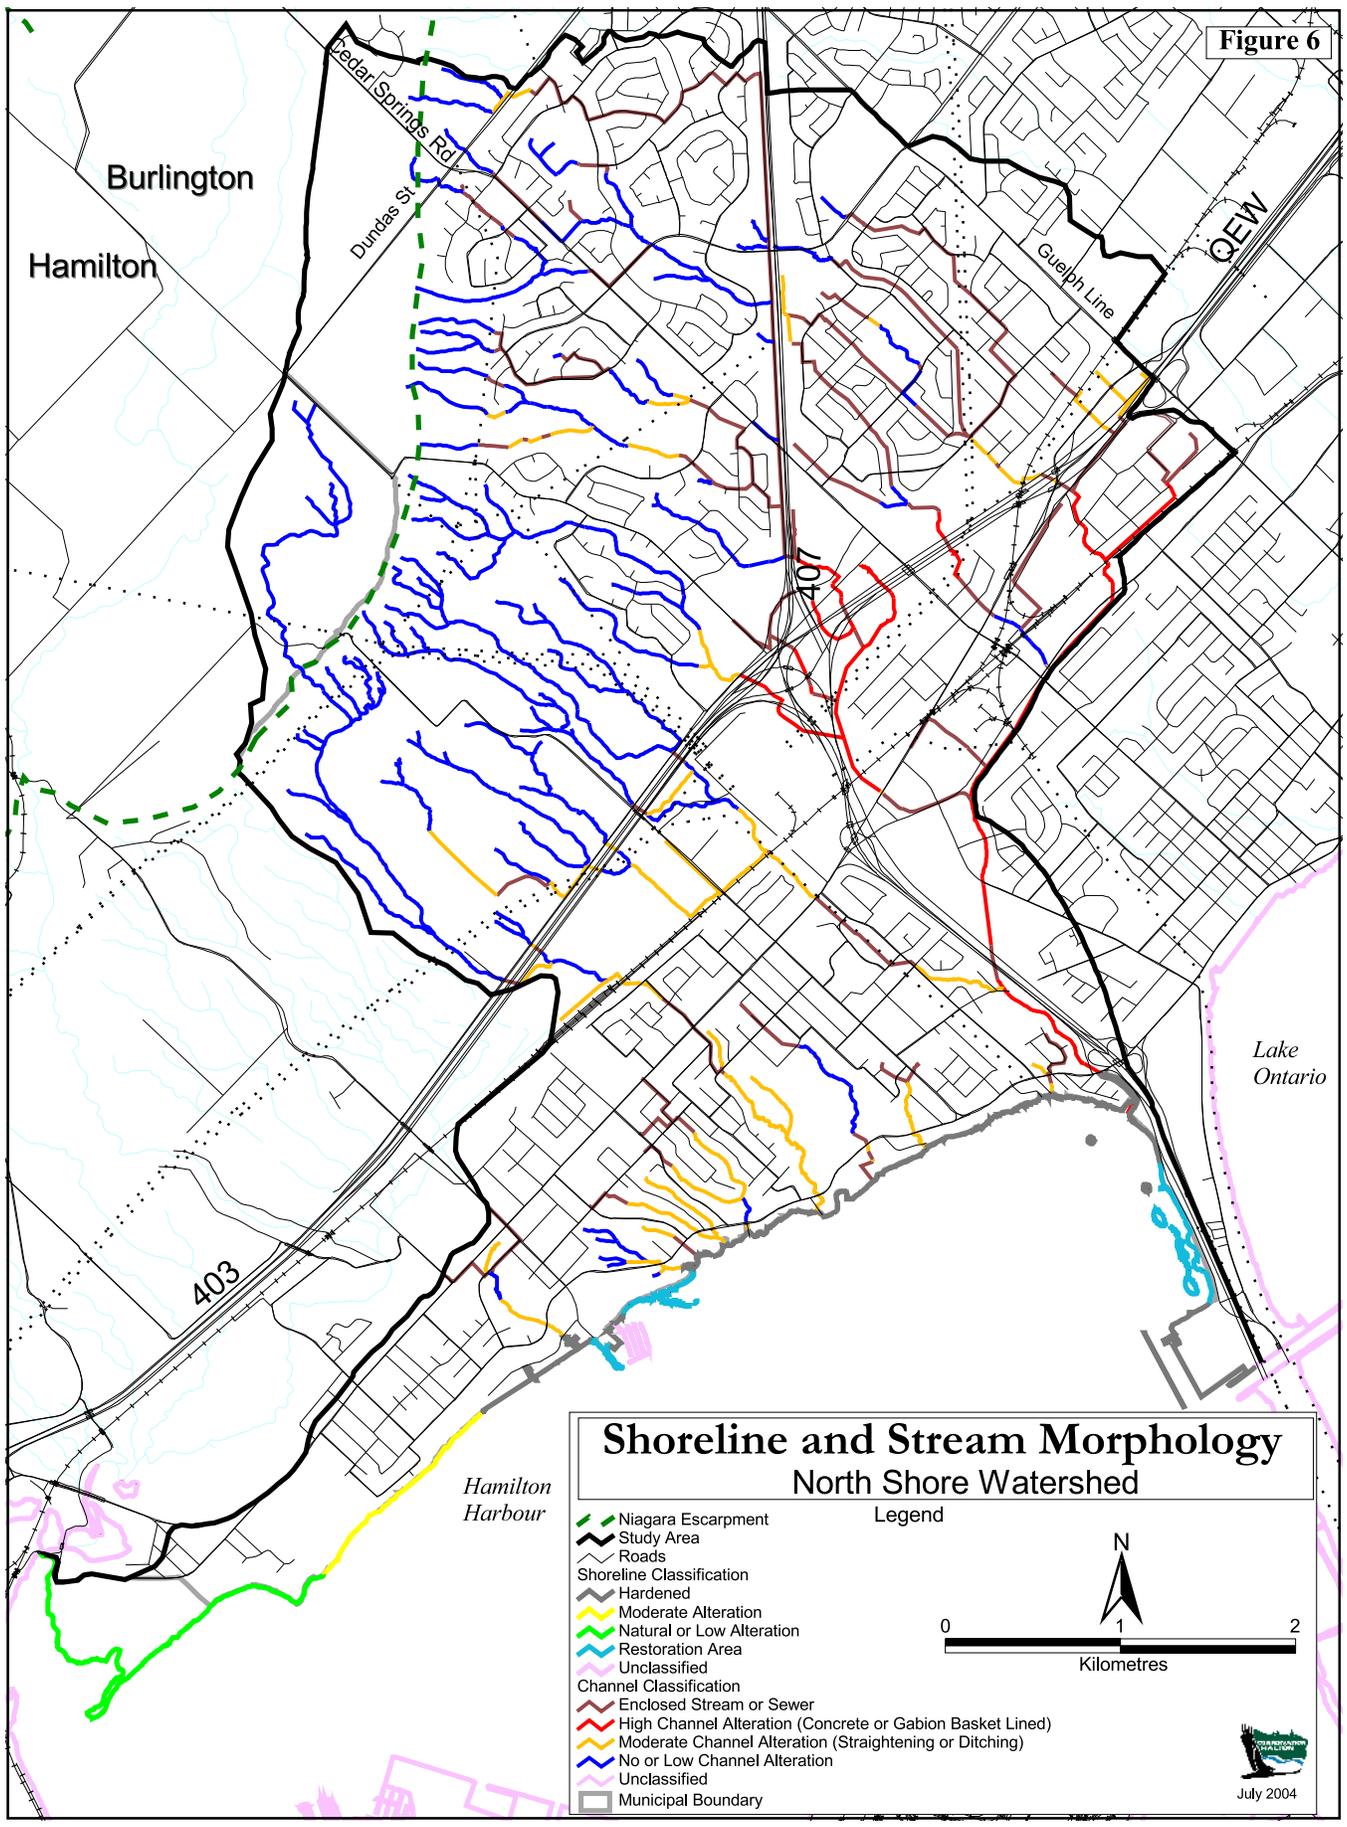
Figure 6

Shoreline and Stream Morphology North Shore Watershed

Urbanization and the demand for development within the watershed have altered the natural state of the shoreline and many of the tributaries and creeks (Figure 6). Due to this urbanization, avenues of infiltration have been removed and urbanized areas have become subject to more intense and flashy runoff events. During spring runoff and large storm events the lower portions of the watercourses may be susceptible to flooding. The flood plain associated with the regional storm has been modelled for Indian Creek and is shown on Figure 7.

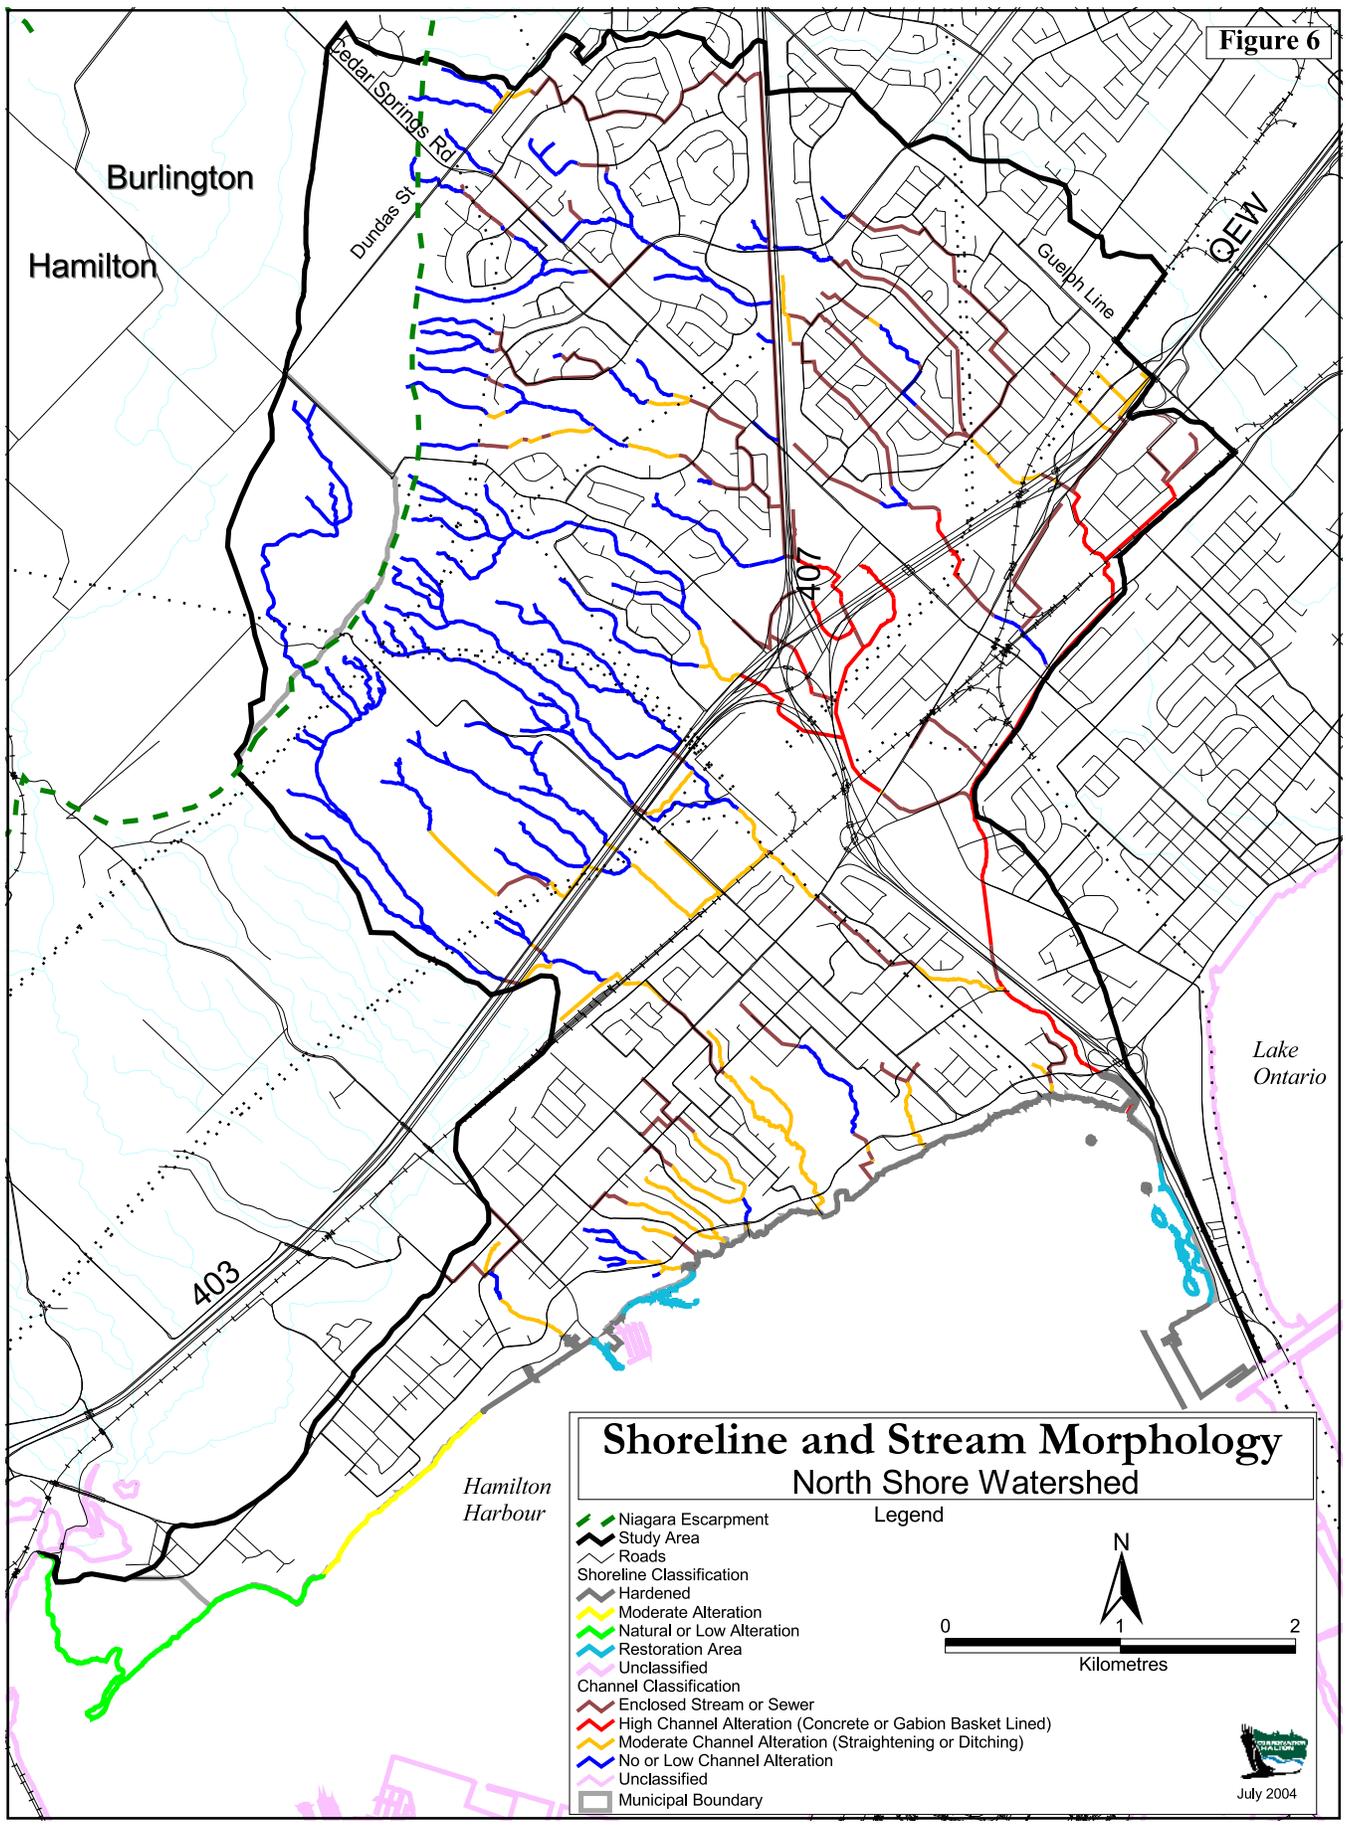
Figure 6

Shoreline and Stream Morphology North Shore Watershed

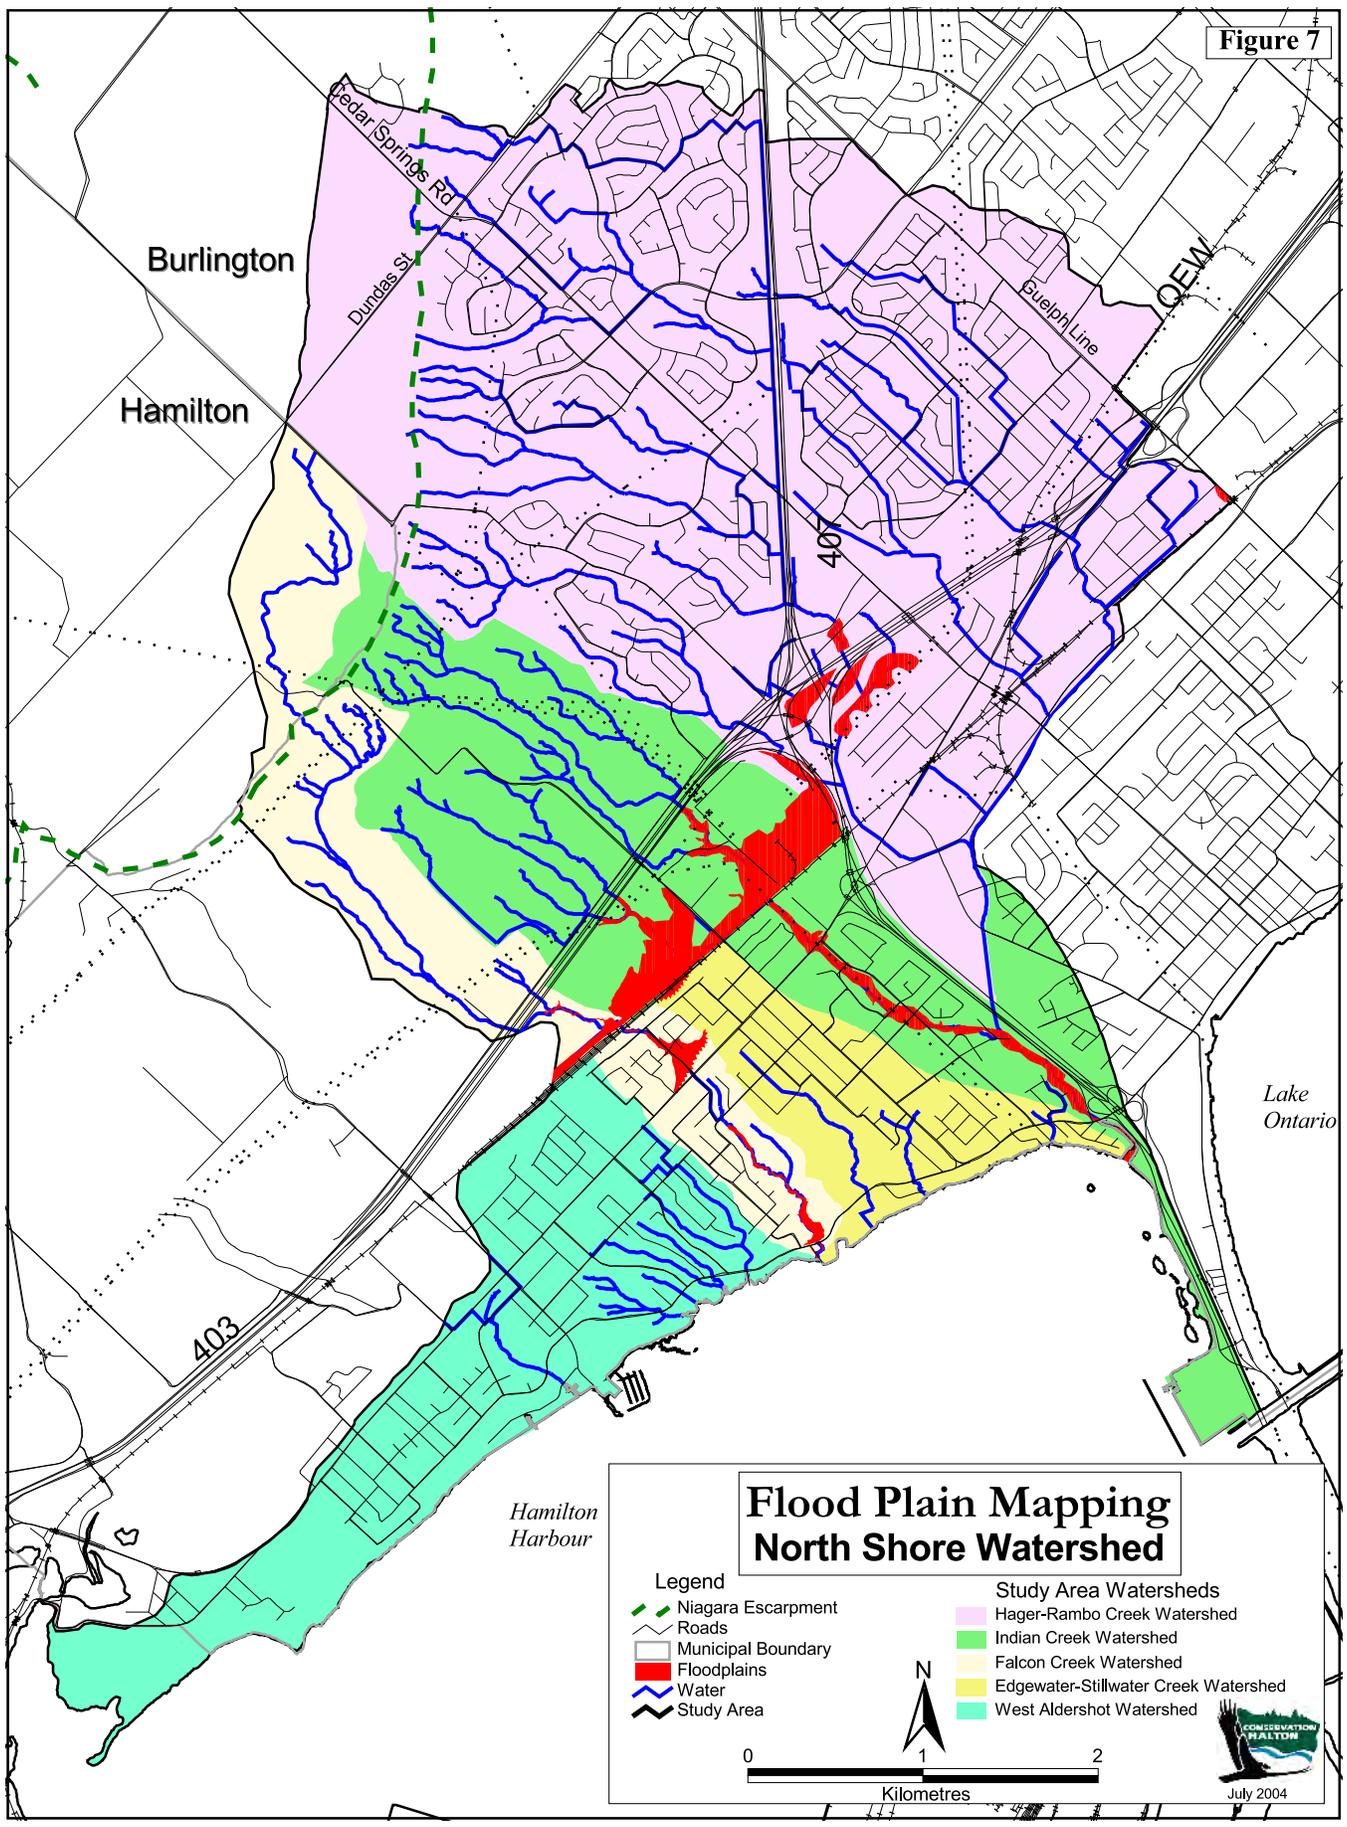
Figure 7

Flood Plain Mapping North Shore Watershed

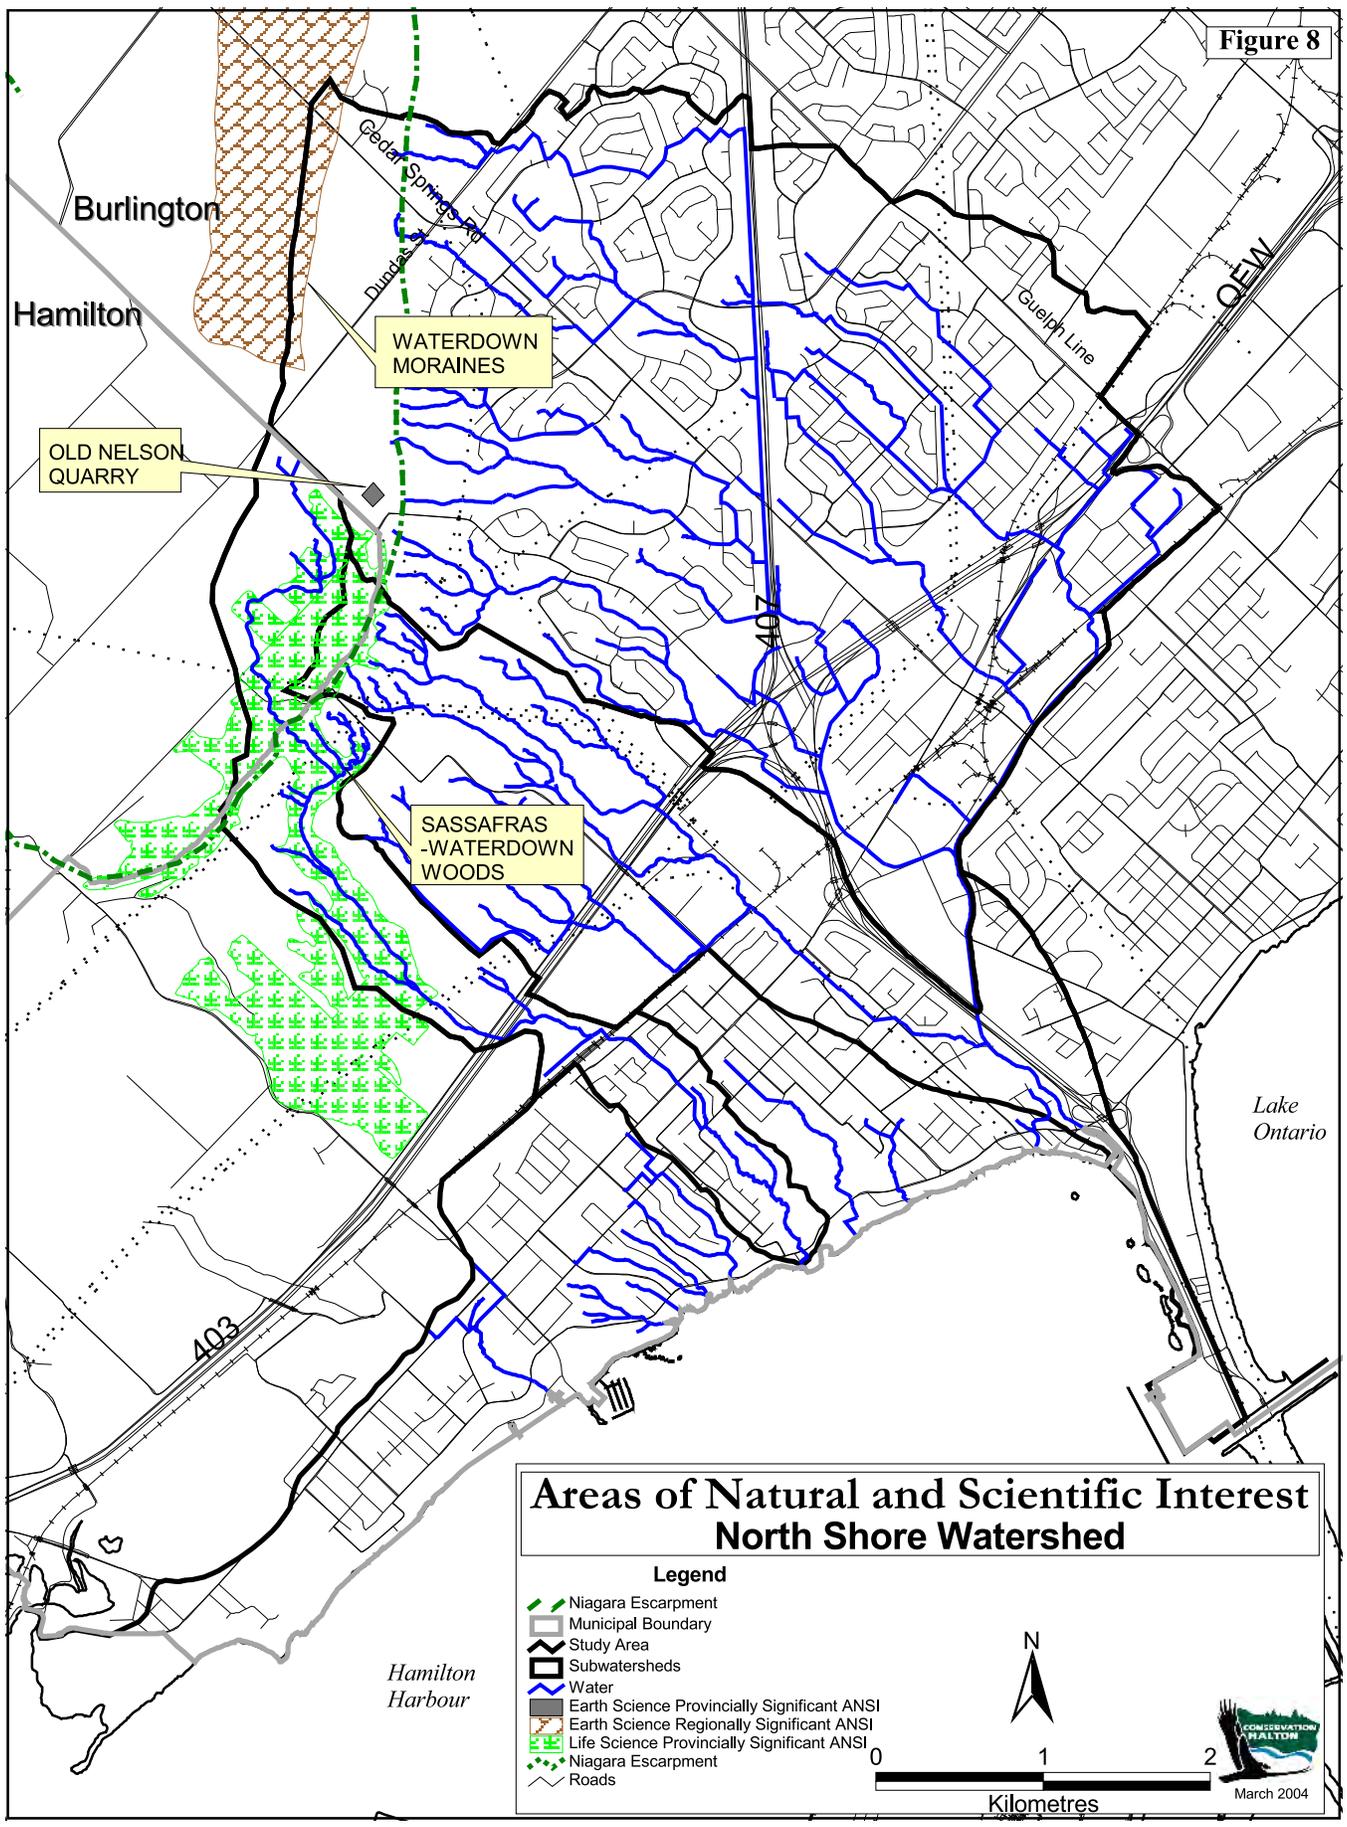
Figure 8

Areas of Natural and Scientific Interest North Shore Watershed

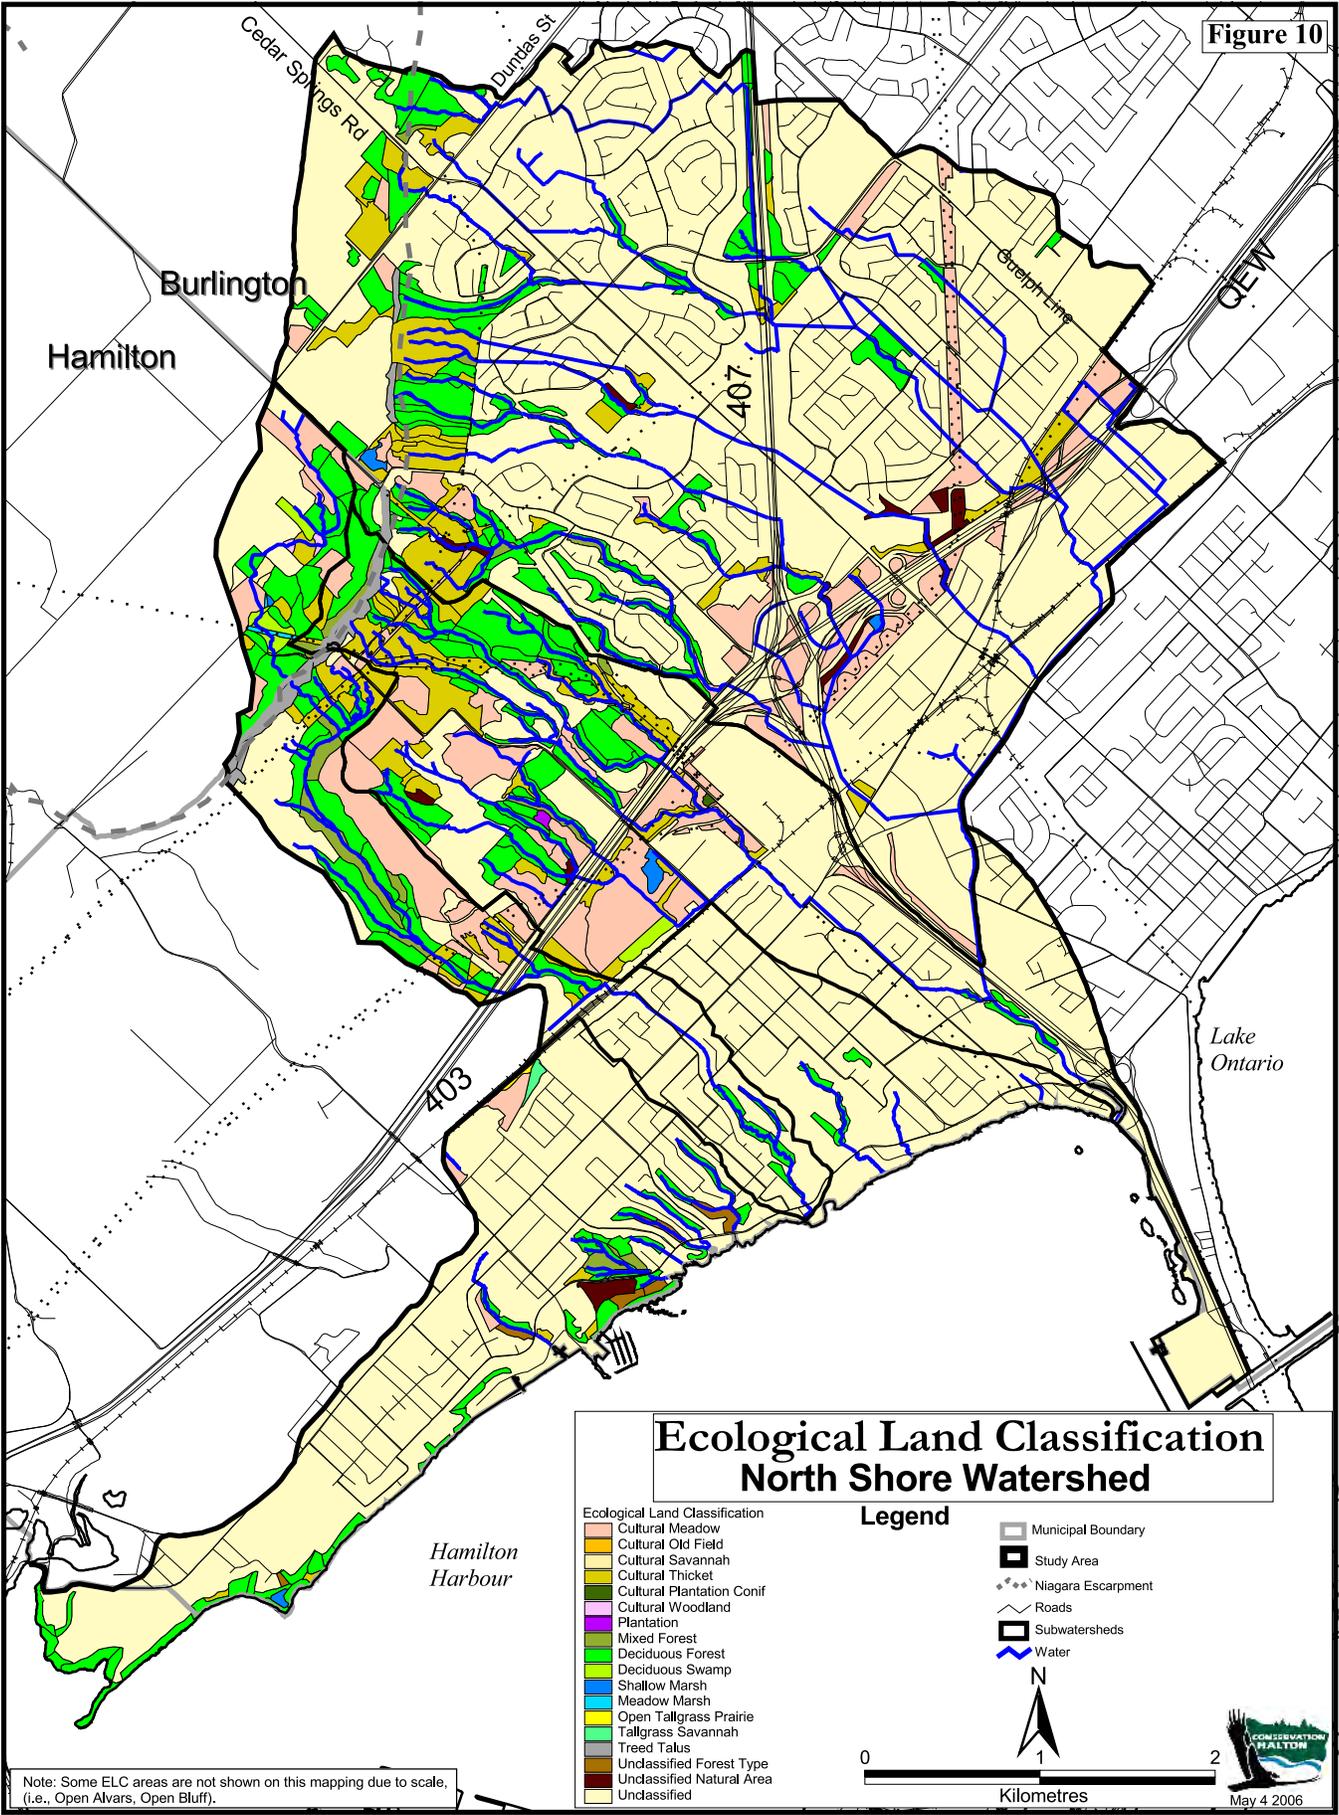
Figure 10

Ecological Land Classification North Shore Watershed
