NORTH SHORE WATERSHED STUDY

North Shore Watershed

Conservation Halton

March 2006

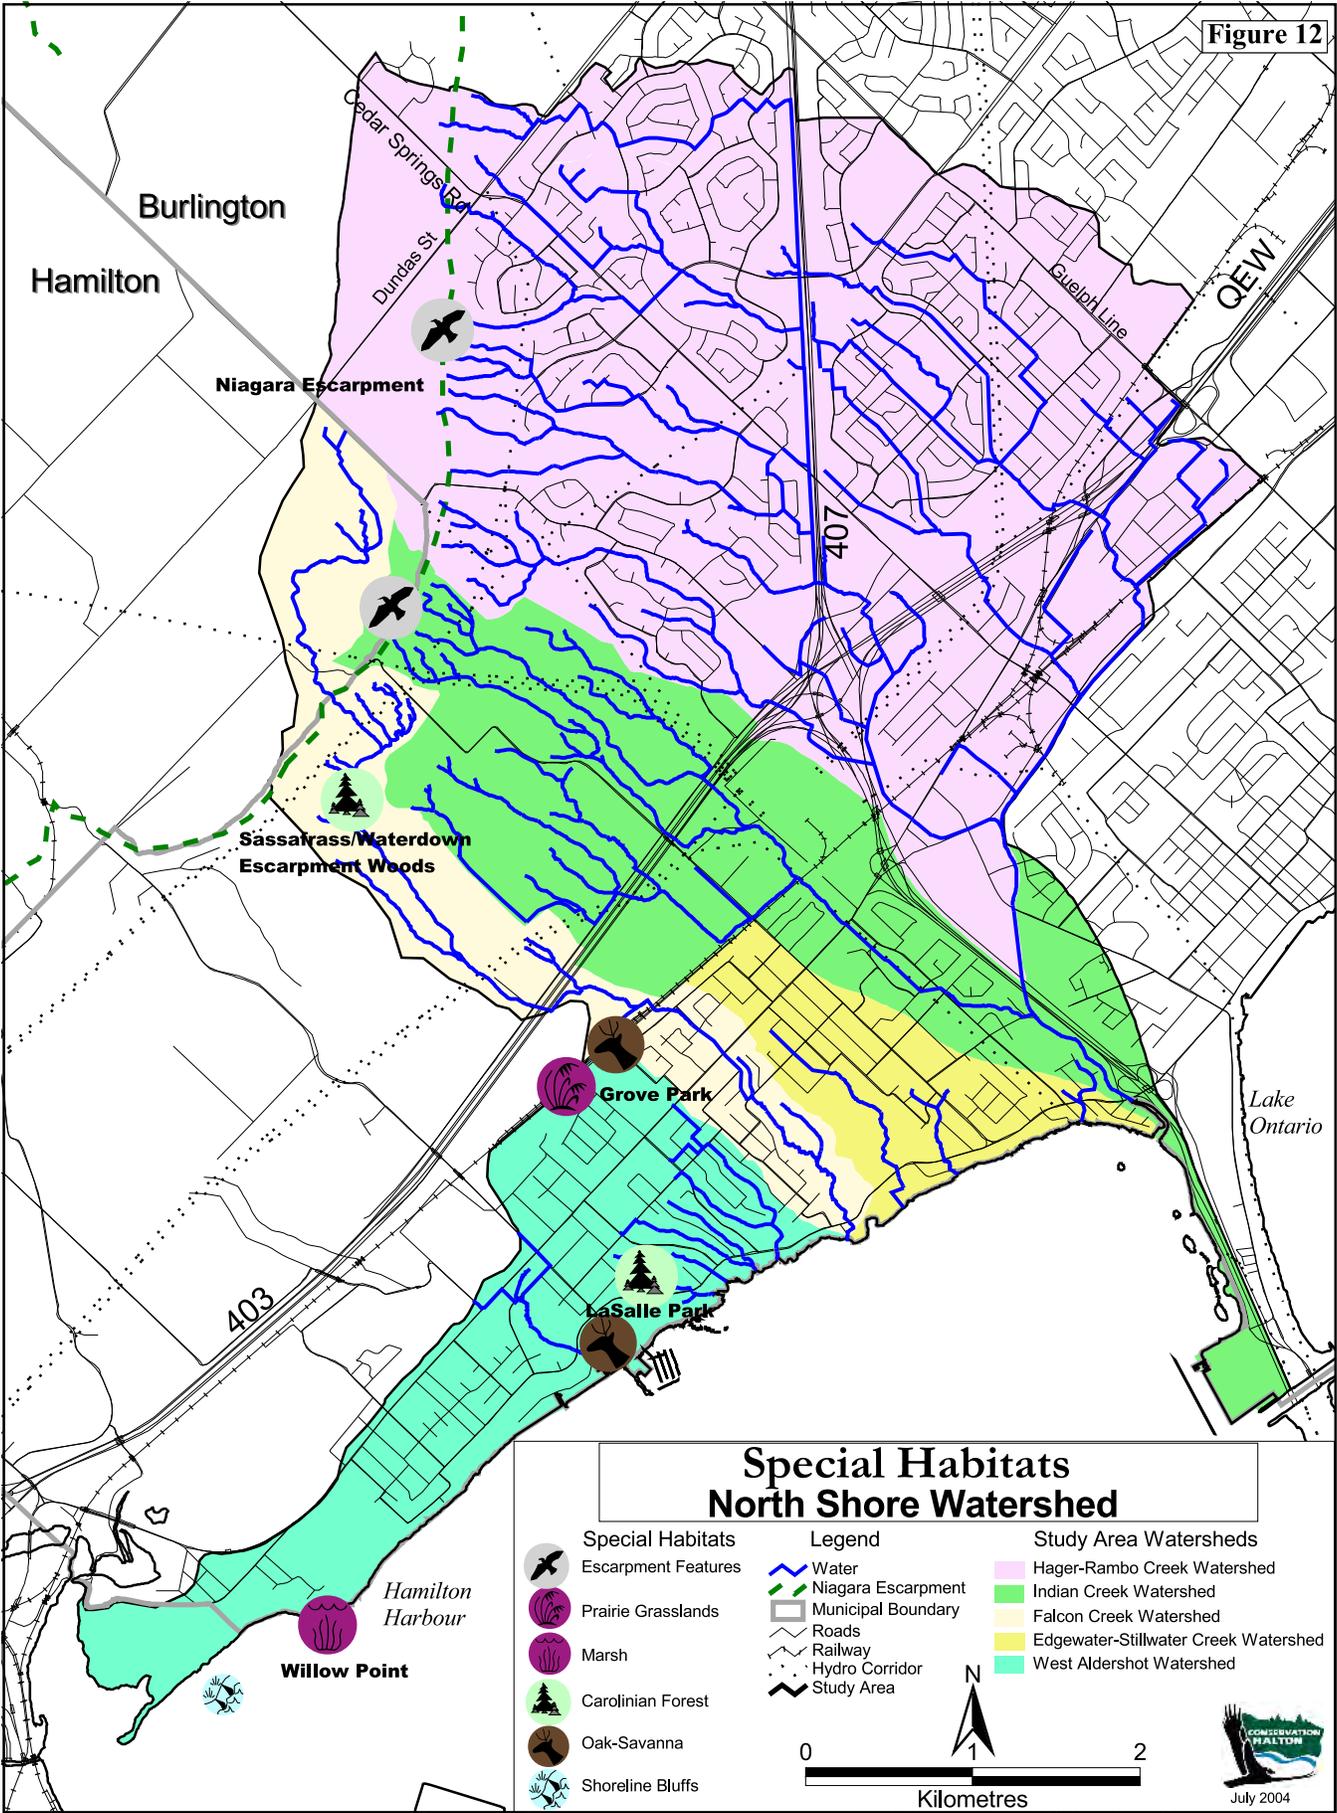
Figure 12

Special Habitats North Shore Watershed

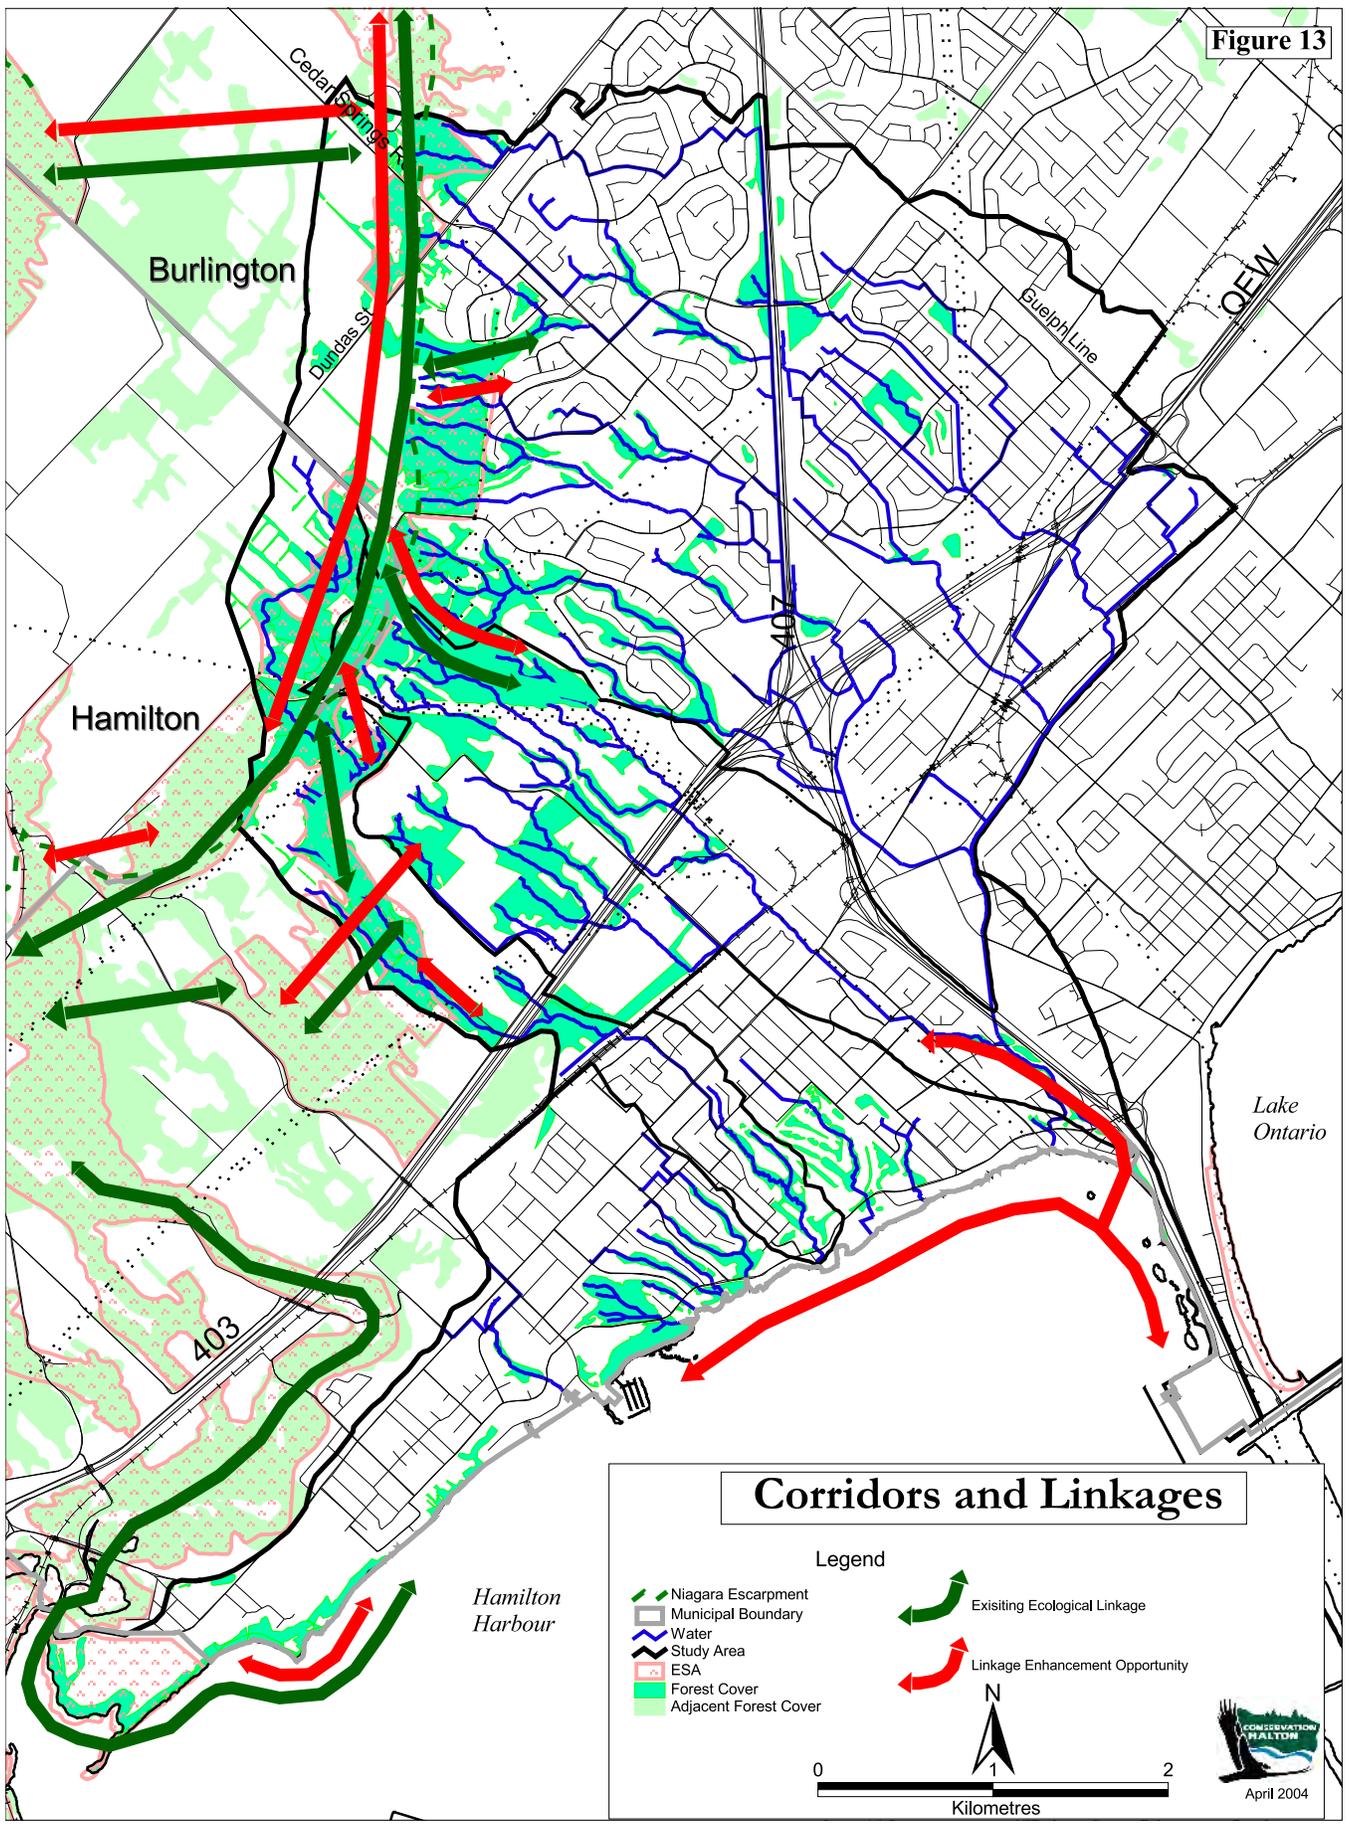
Figure 13

Corridors and Linkages

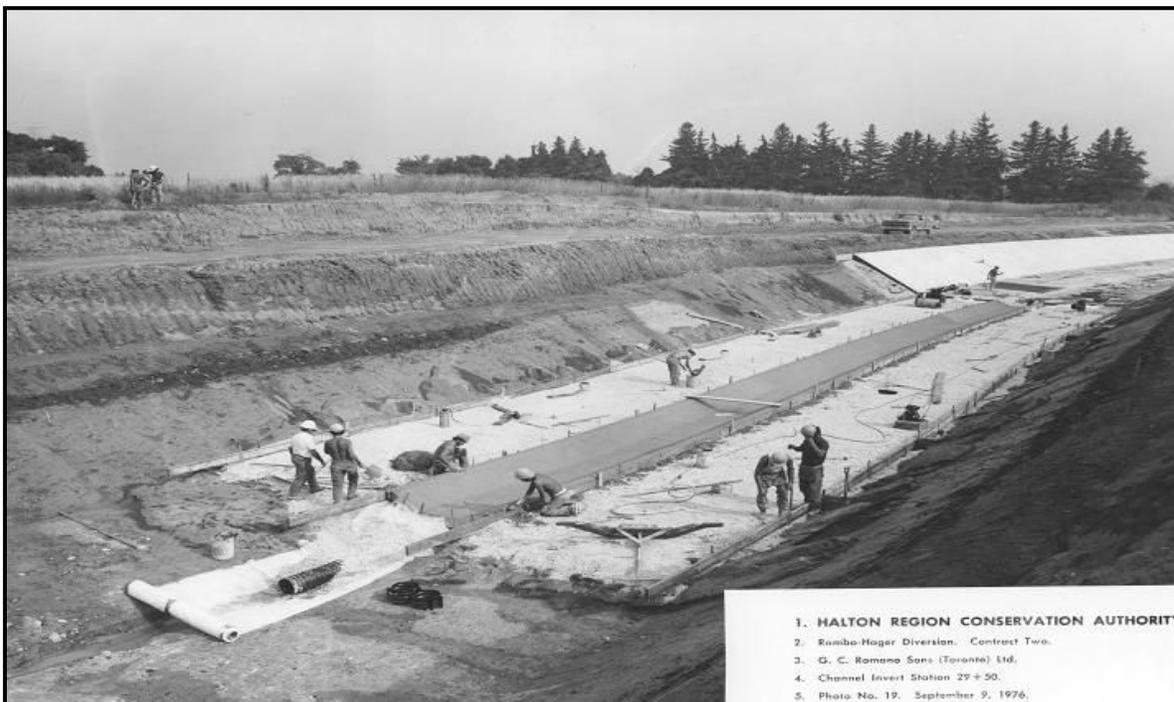
Hager-Rambo Diversion Channel Under Construction

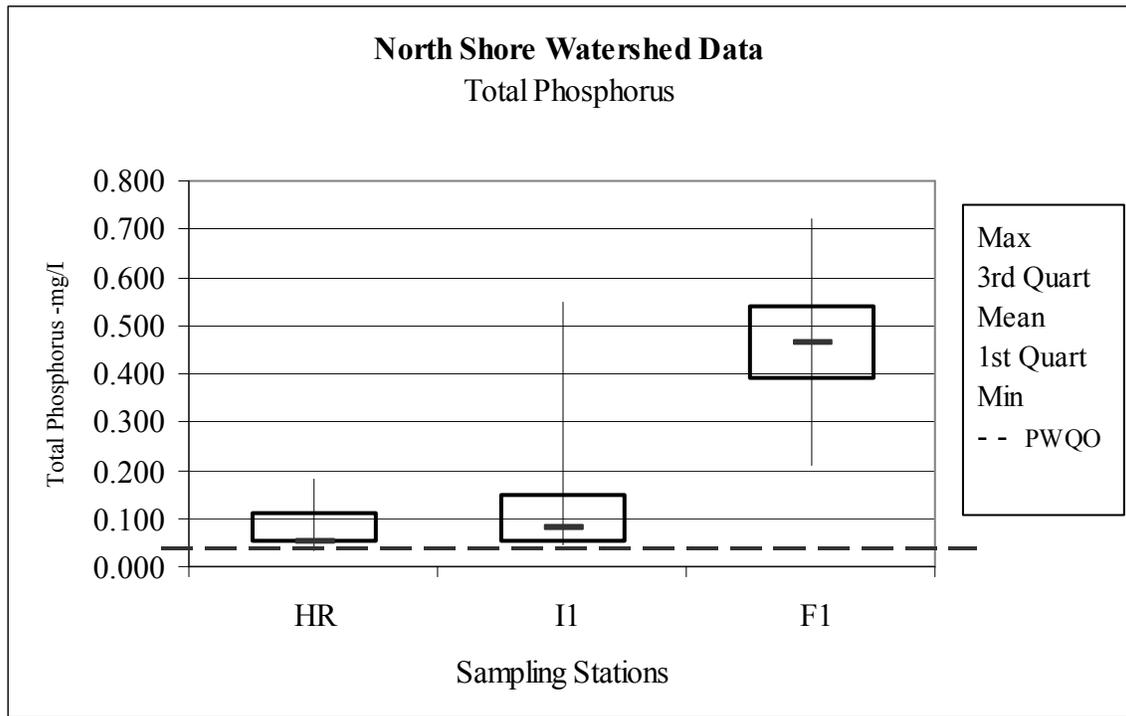
Table 9. Total Phosphorus at three stations within the North Shore Watershed.

Table 9 summarizes Total Phosphorus concentrations at the three key stations in the North Shore watershed. Table 10 summarizes *E. coli* concentration at the same stations.

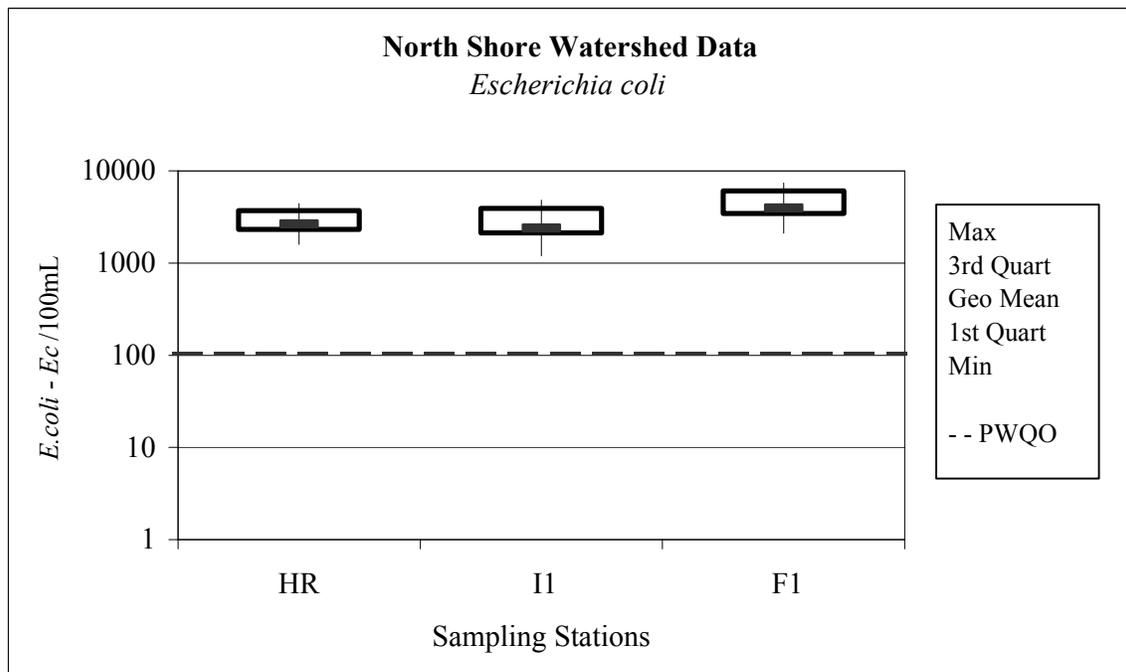
Table 10. *E. coli* at three stations within the North Shore Watershed.

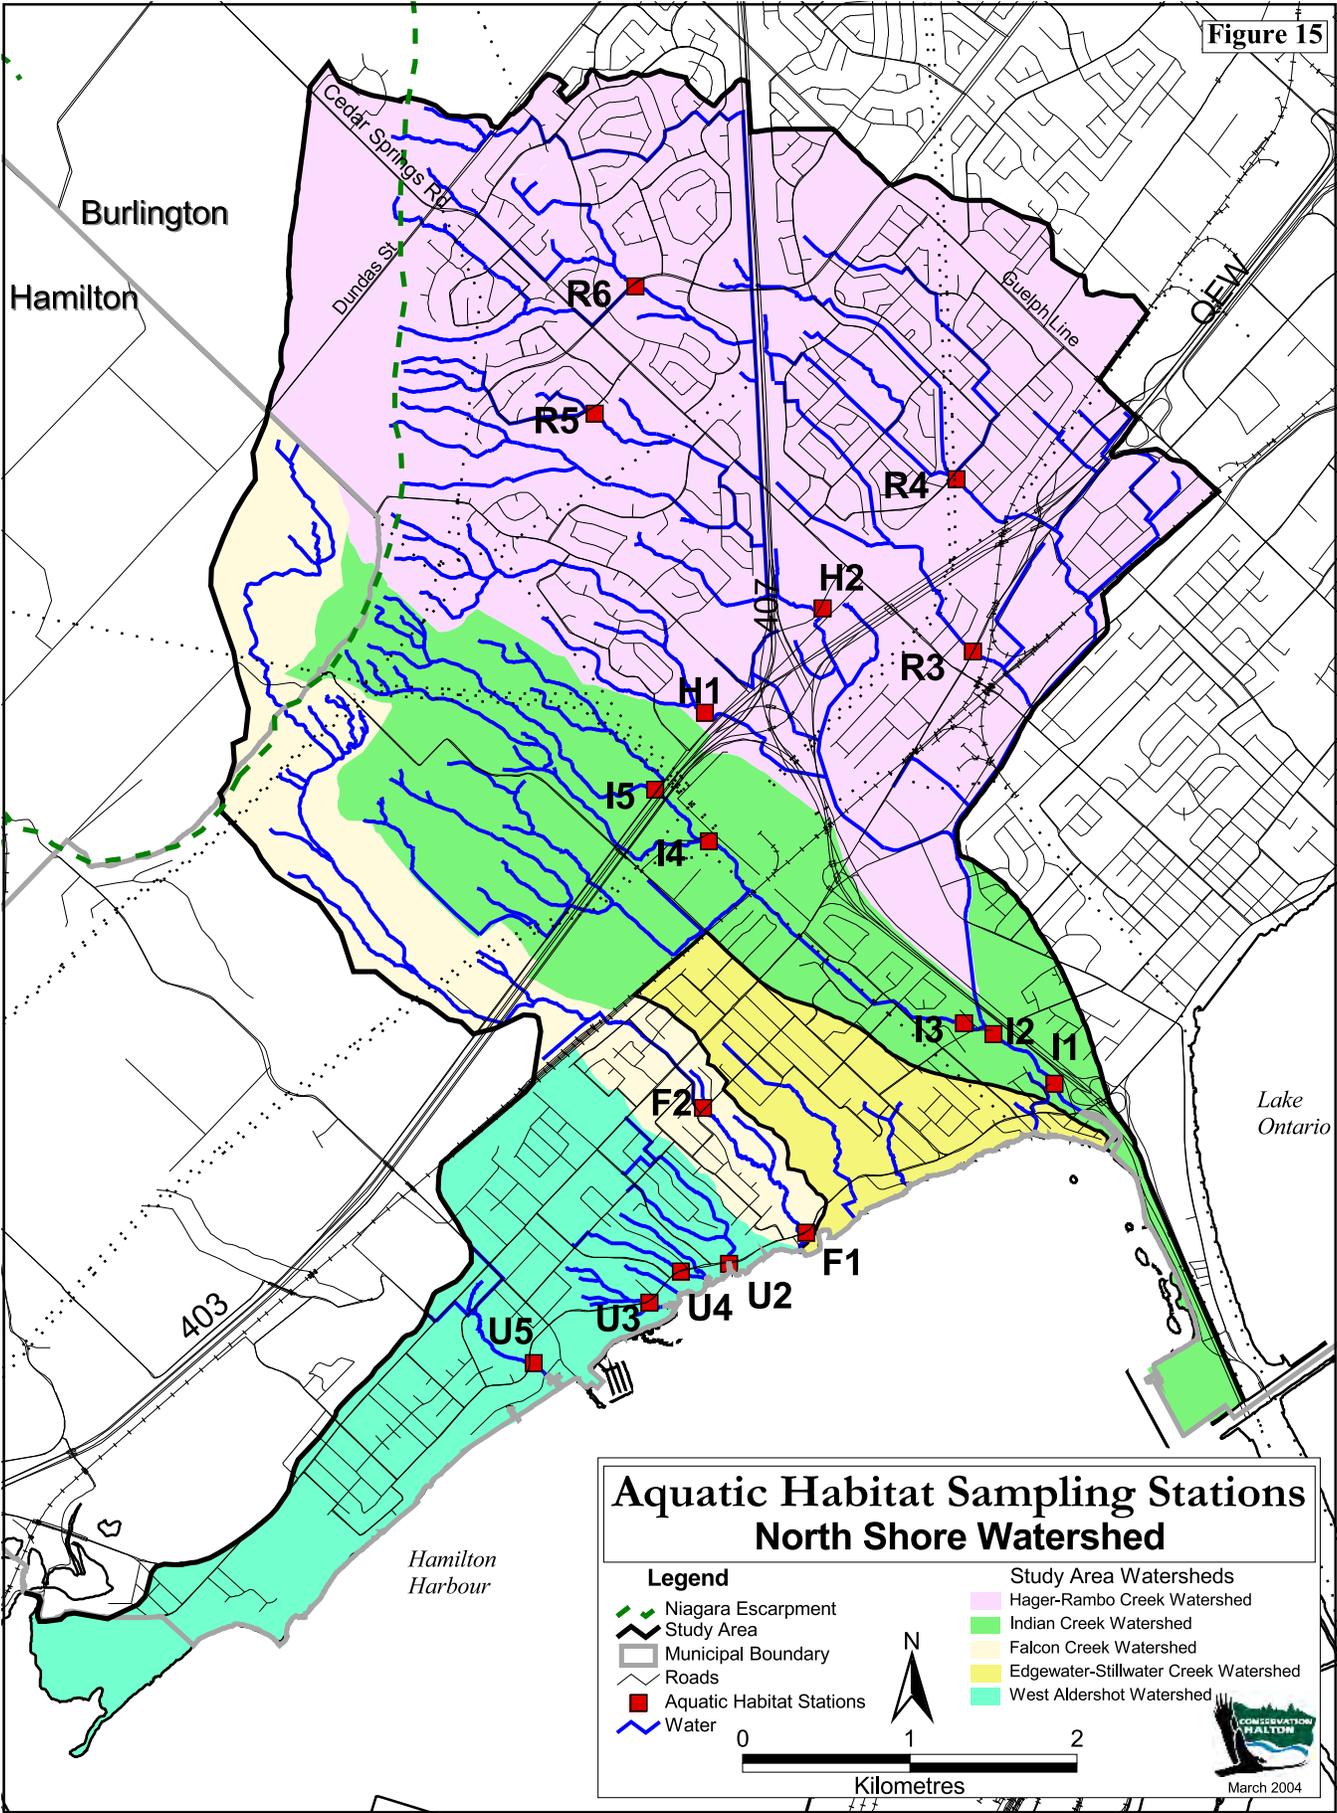
Figure 15

Aquatic Habitat Sampling Stations North Shore Watershed

Sixteen stations were sampled using this methodology on August 7, 2001 and July 9, 2002 (Figure 15). The distribution of instream temperature stations by tributary and subreach is provided in Table 11. Results of station sampling are provided in Appendix 5.

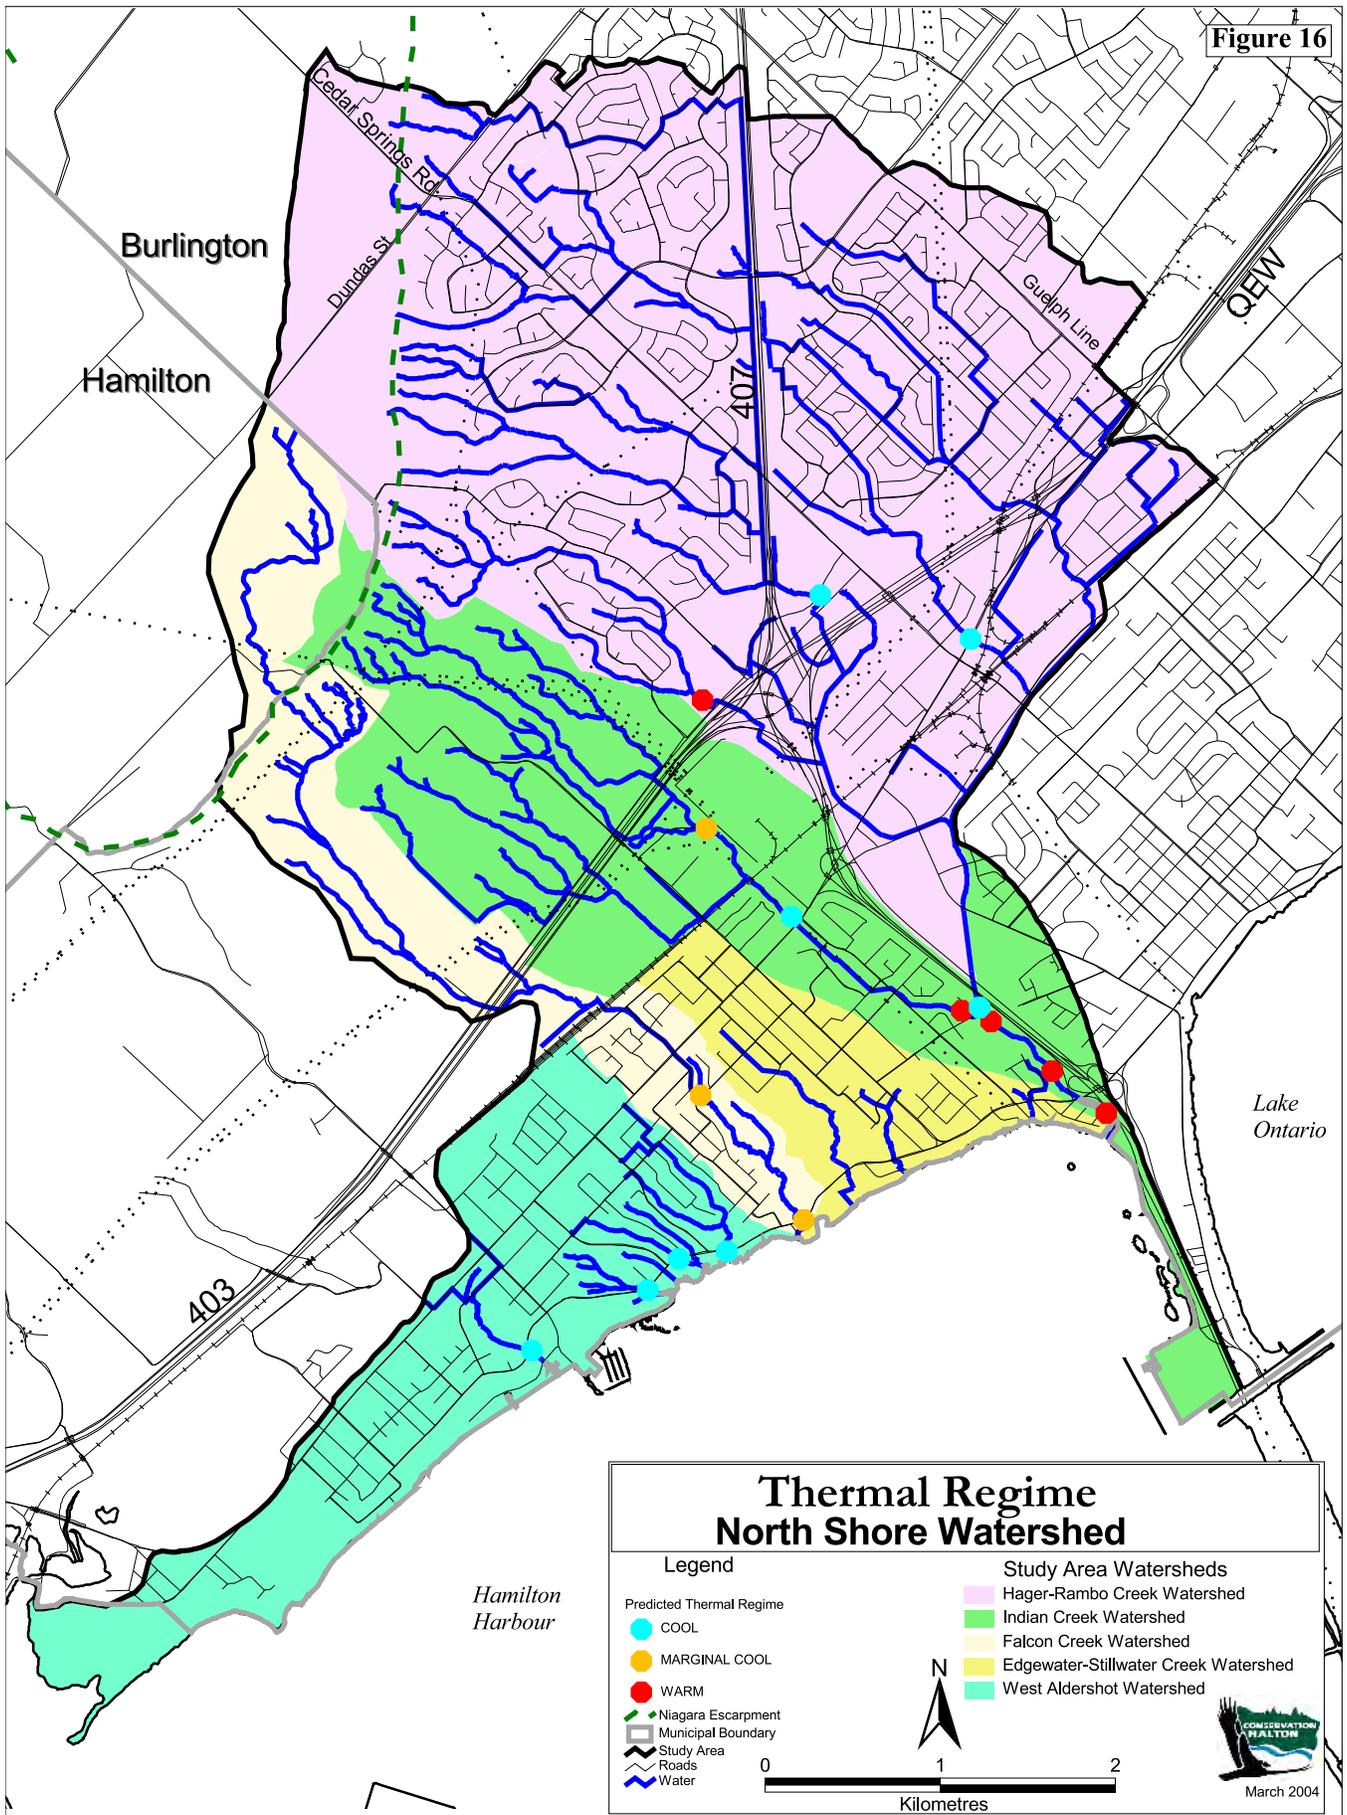
Figure 16

Thermal Regime North Shore Watershed

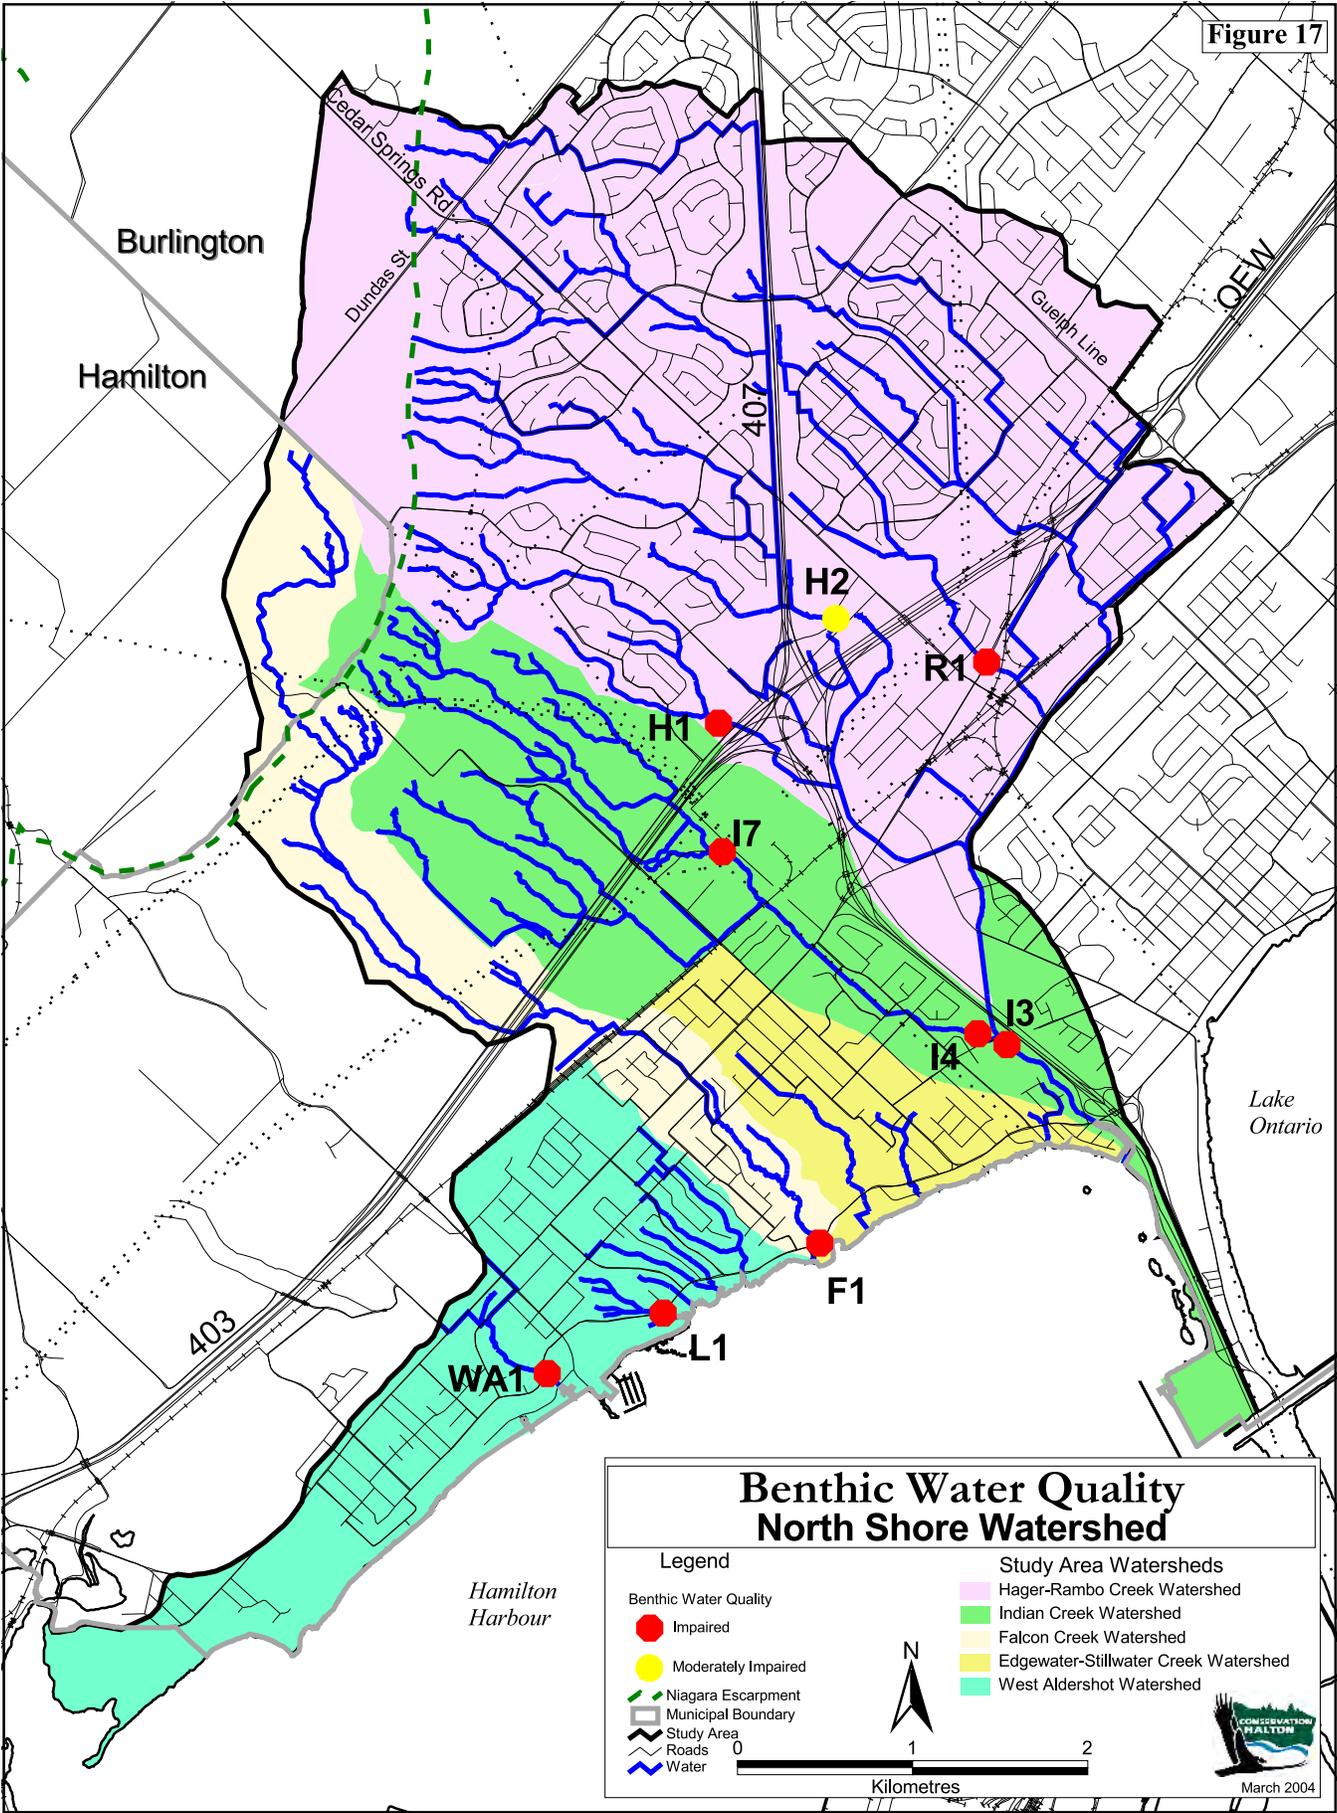
Figure 17

Benthic Water Quality North Shore Watershed

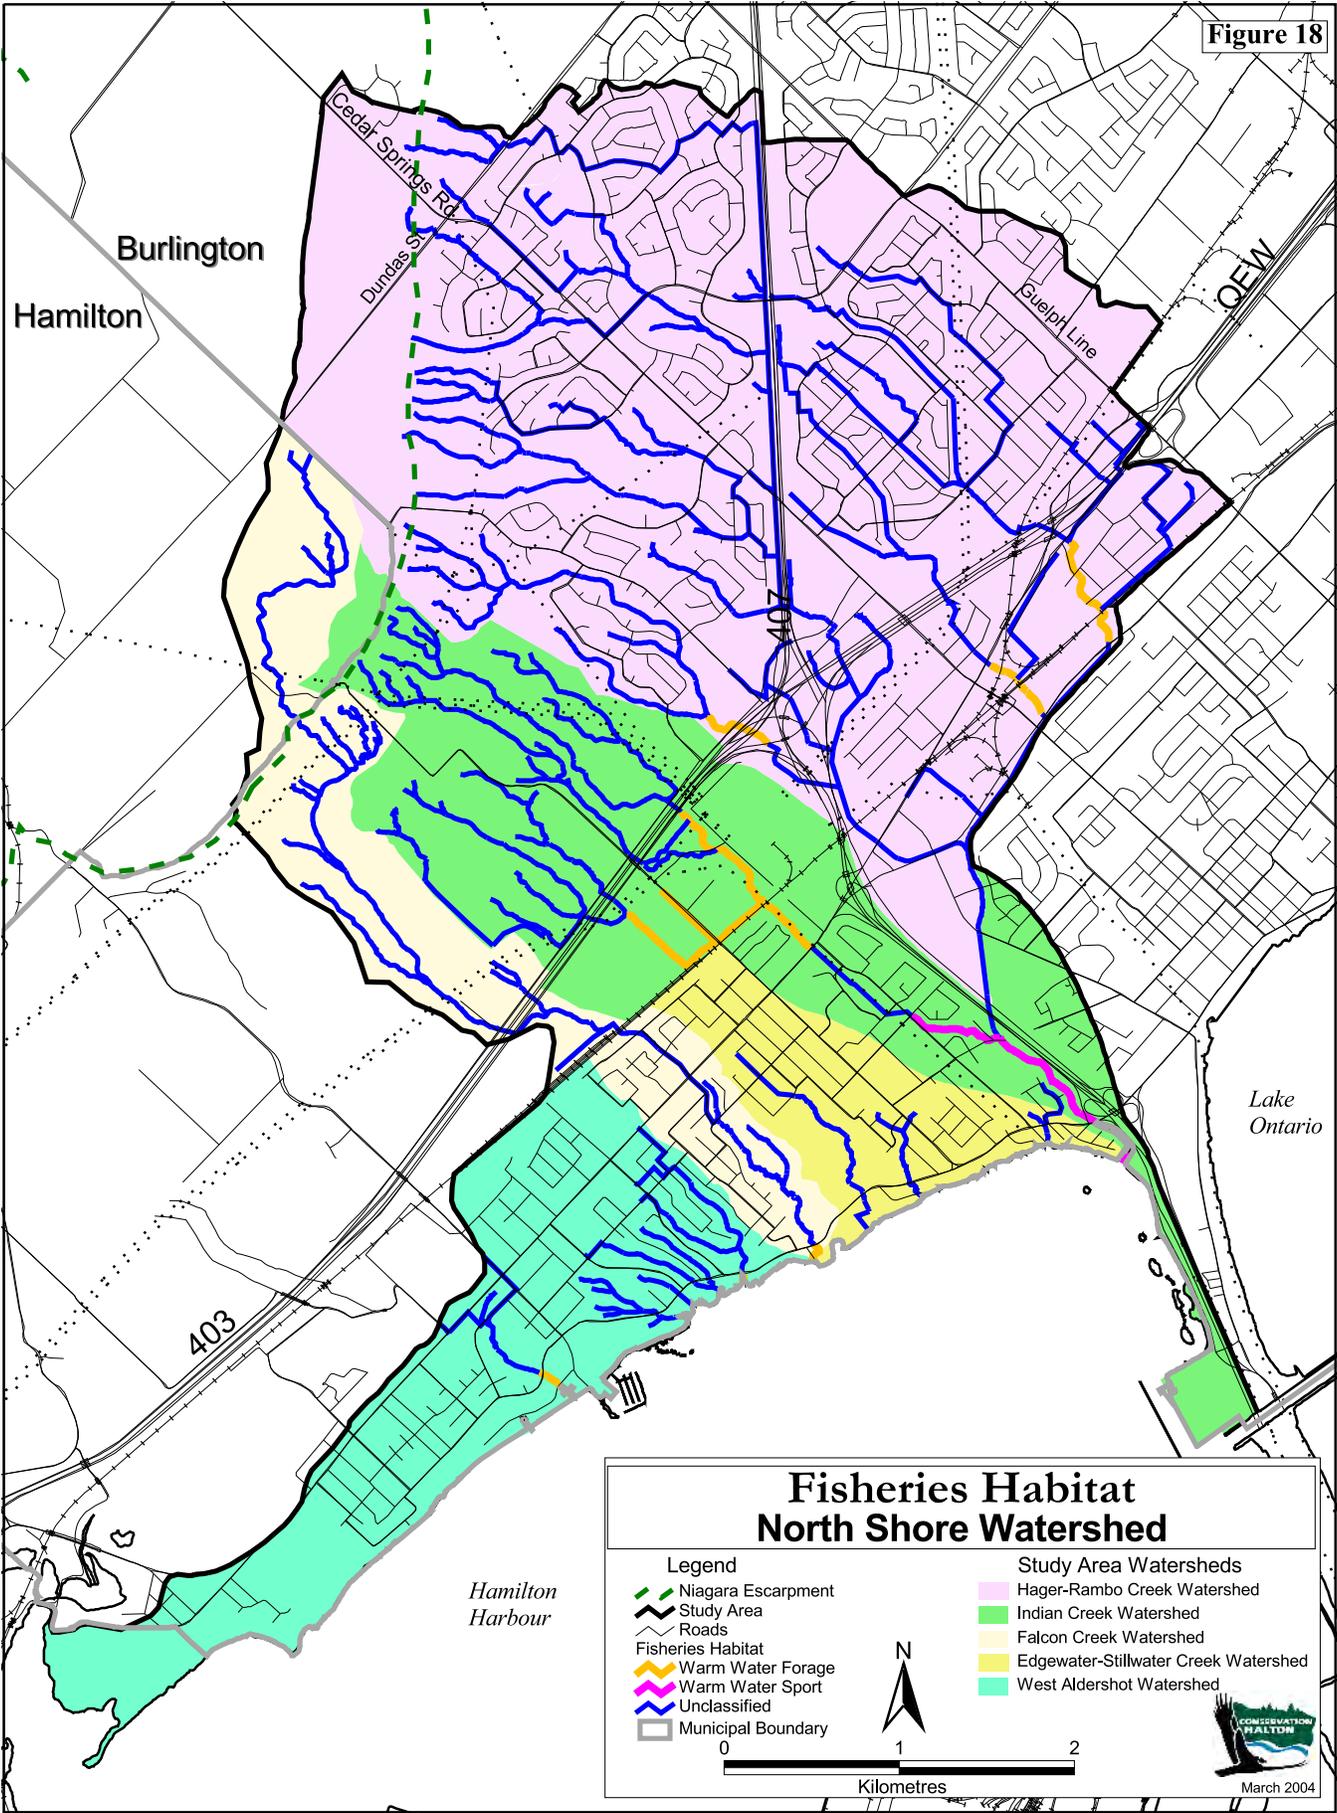
Figure 18

Fisheries Habitat North Shore Watershed

channels (Figure 18). Sampling in support of this study and 1998 sampling in support of a Highway 403 (EcoTec, 1999) study indicate the fish community in Hager Creek is limited to remnant populations of creek chub, common shiner, and white sucker found in the lower reaches of West Hager. Previous sampling efforts in the east branch of Hager Creek, upstream of North Service Road did not yield any results. In 2001, a single carp (*Cyprinus carpio*) was captured during the course of this study.
