Sixteen Mile Creek

1958

conservation
report

SIXTEEN
MILE
CREEK
CONSERVATION
REPORT
1958

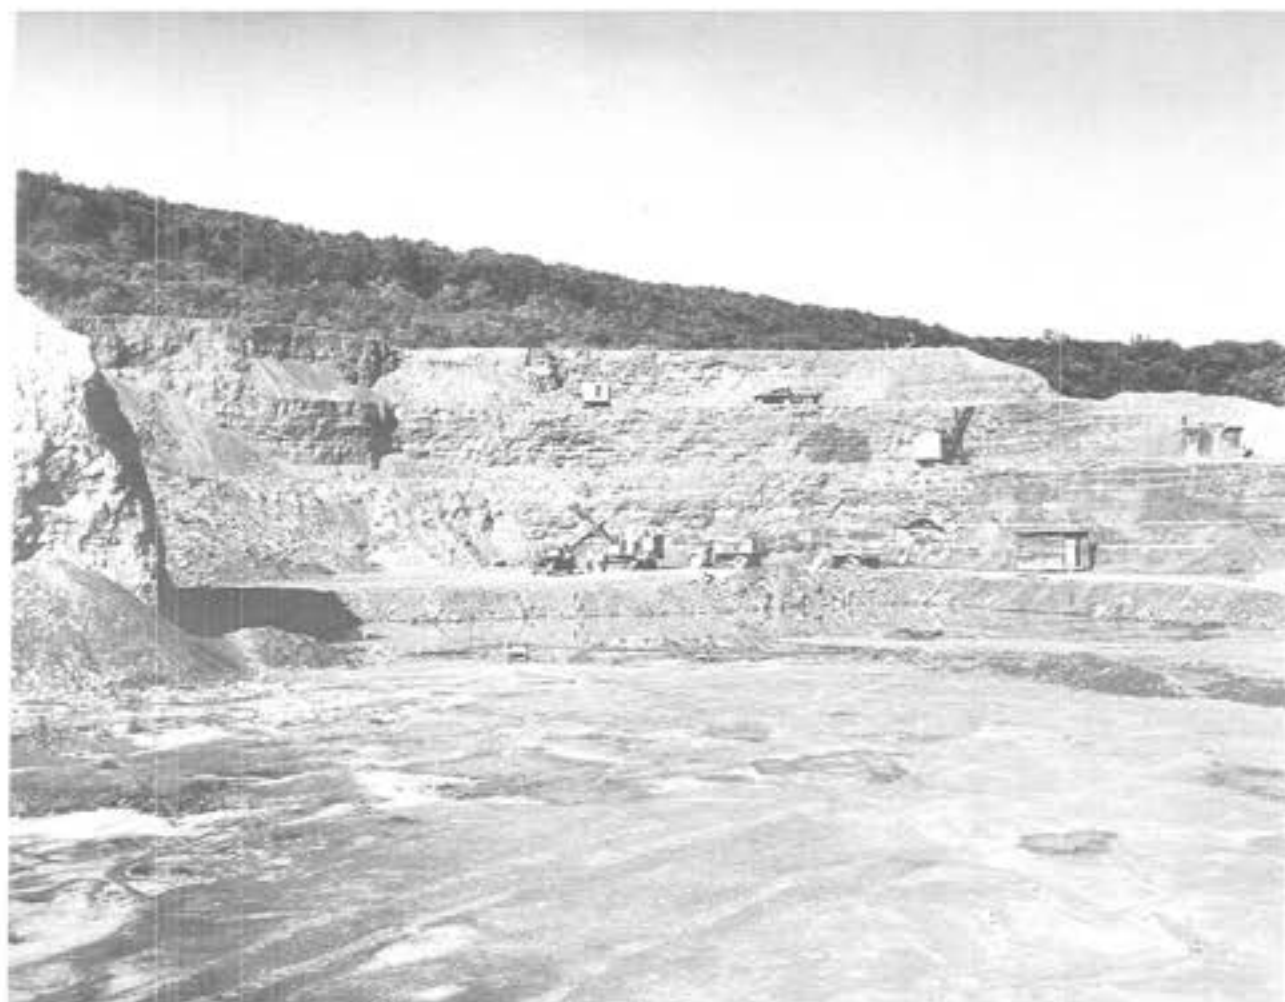
West of Milton the dark red (green banded) shales of the Queenston formation are used in the manufacture of brick.

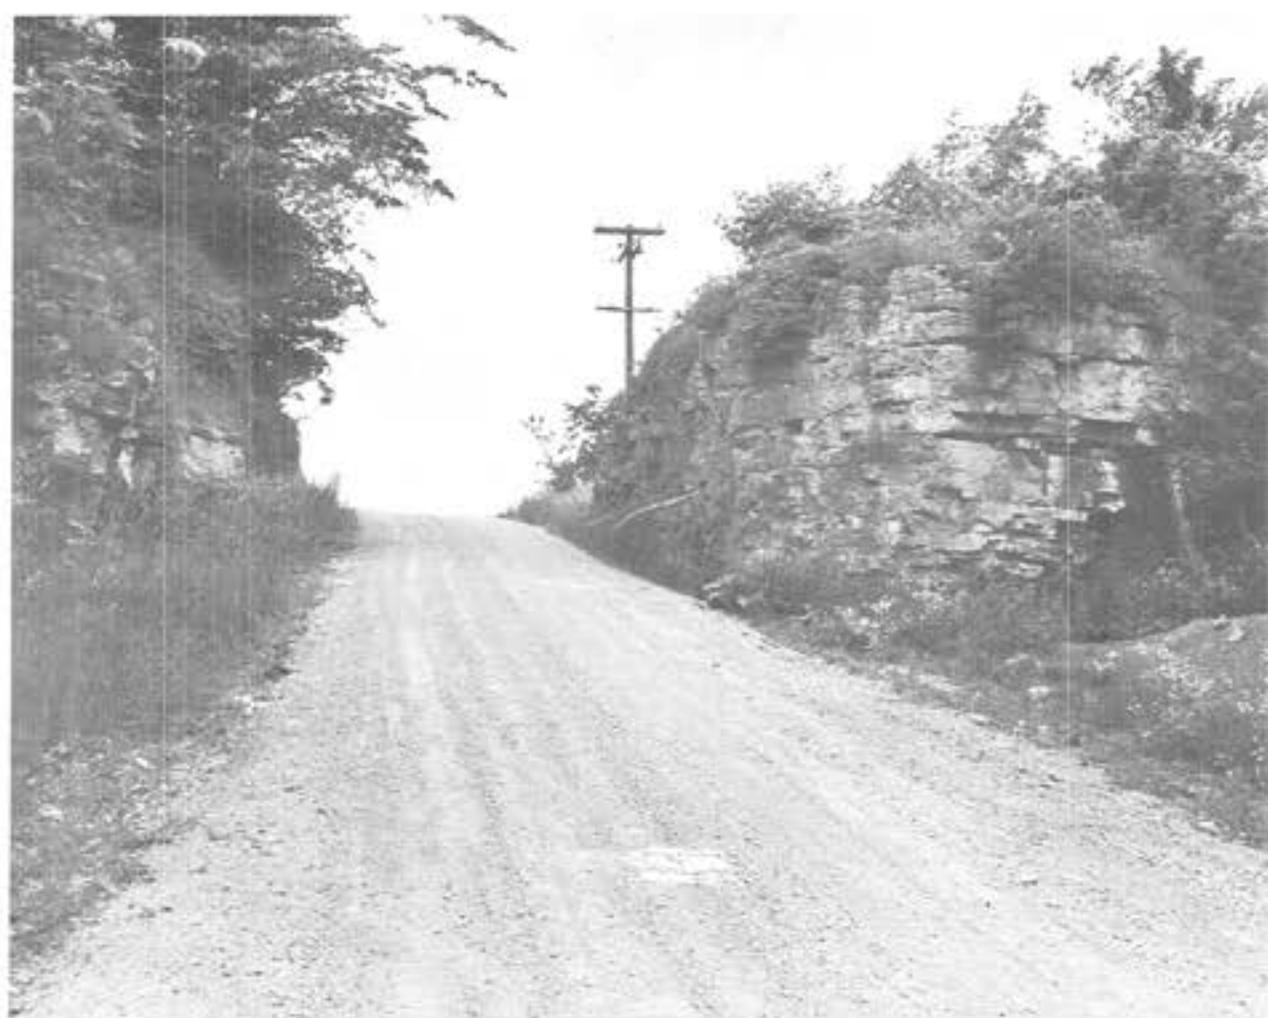
Hard Limestone caps the softer underlying shales to form the Niagara escarpment.

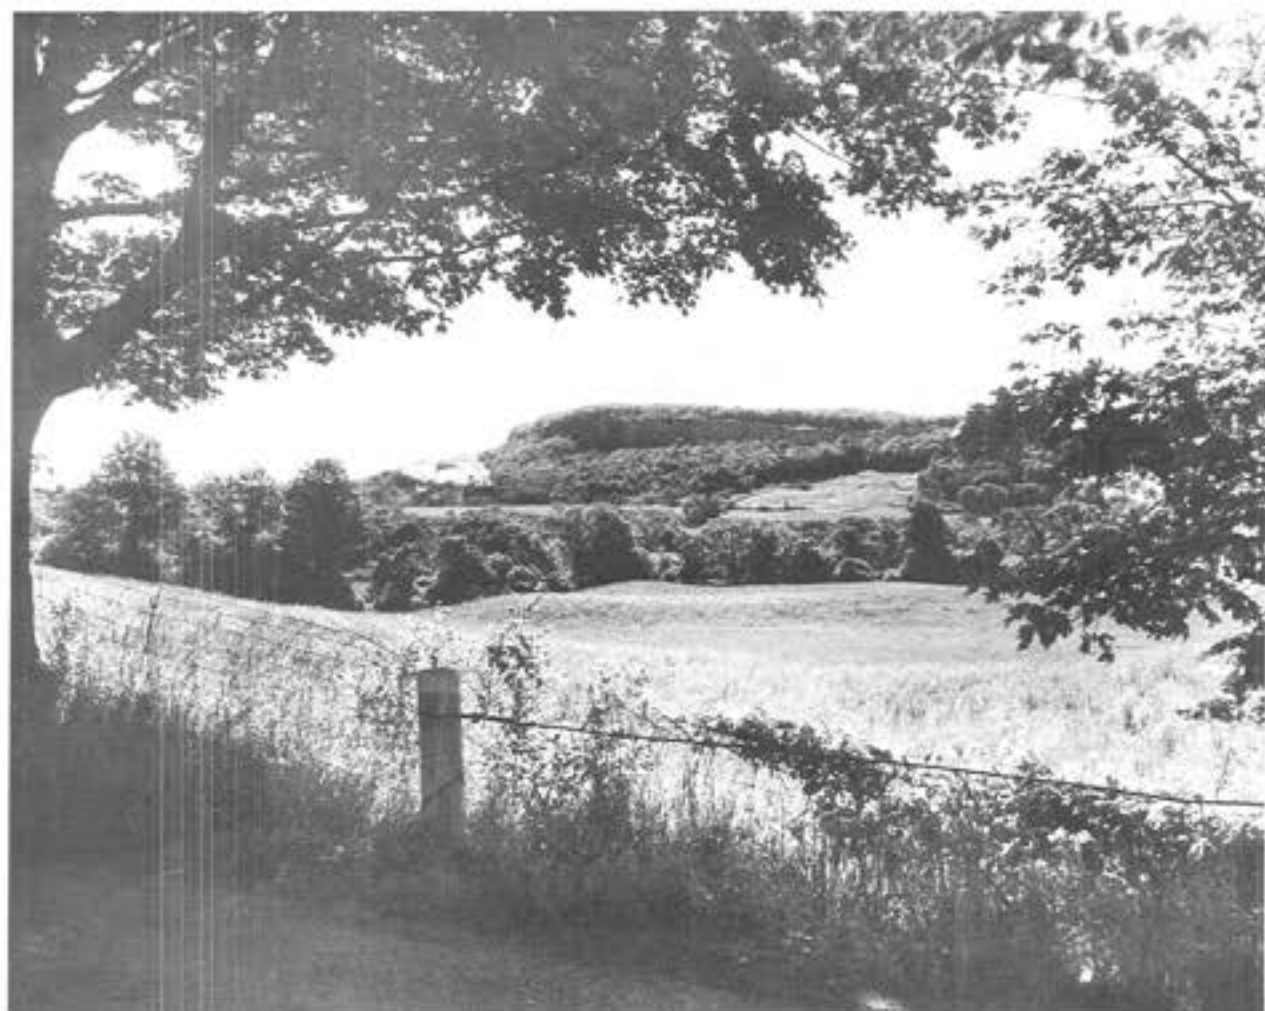
The Niagara escarpment is the most striking physiographic feature in the watershed.

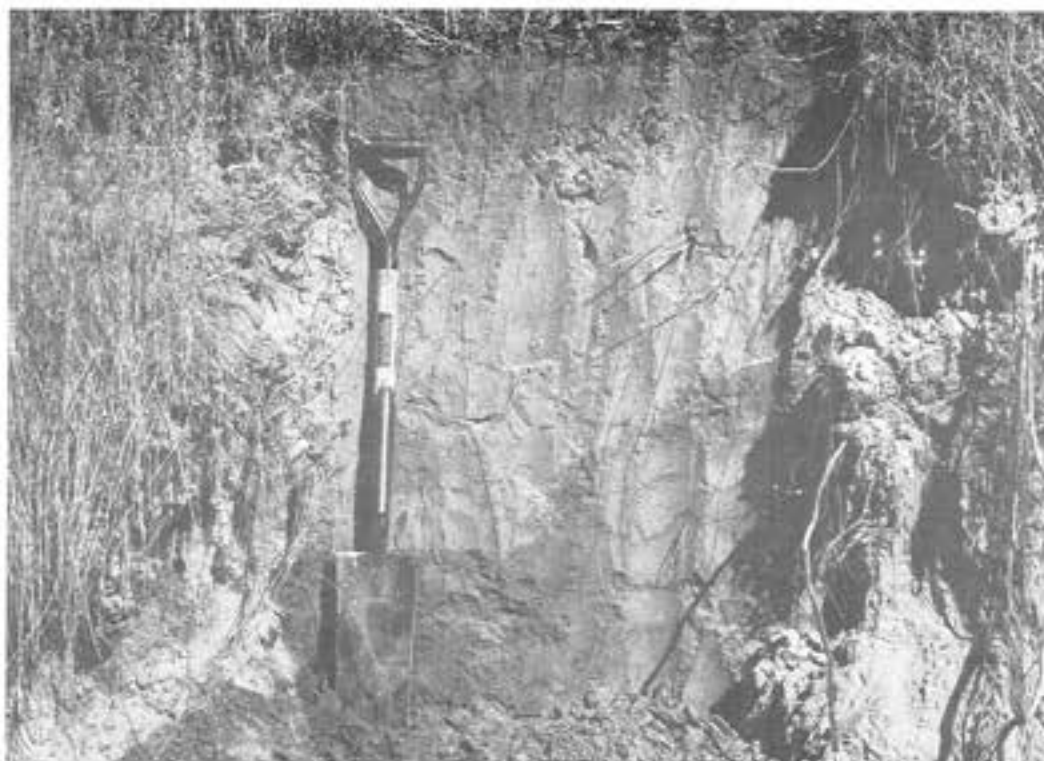
Fox sandy loam. Note the well defined A and A2 horizons. Because of a moist subsoil the narrow B horizon is a little indistinct.

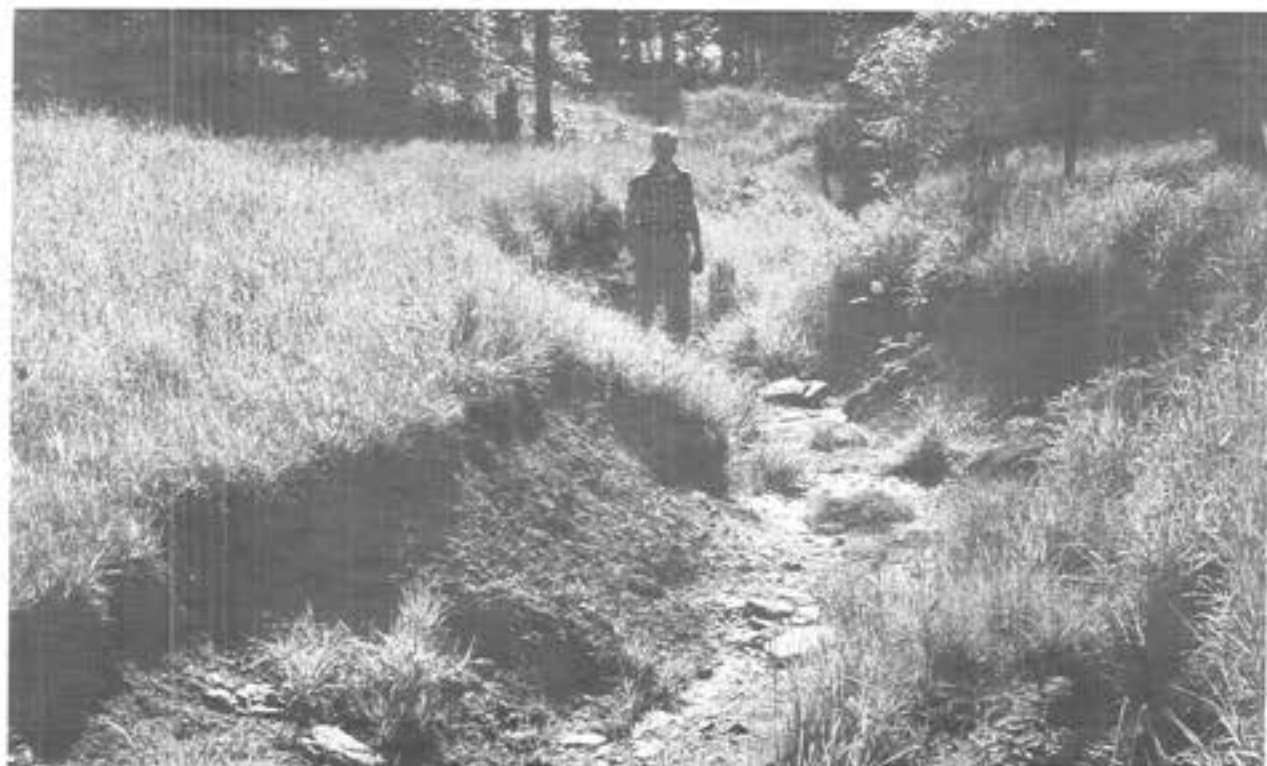
Gully erosion is serious in many places and can often be prevented through the use of grassed waterways.

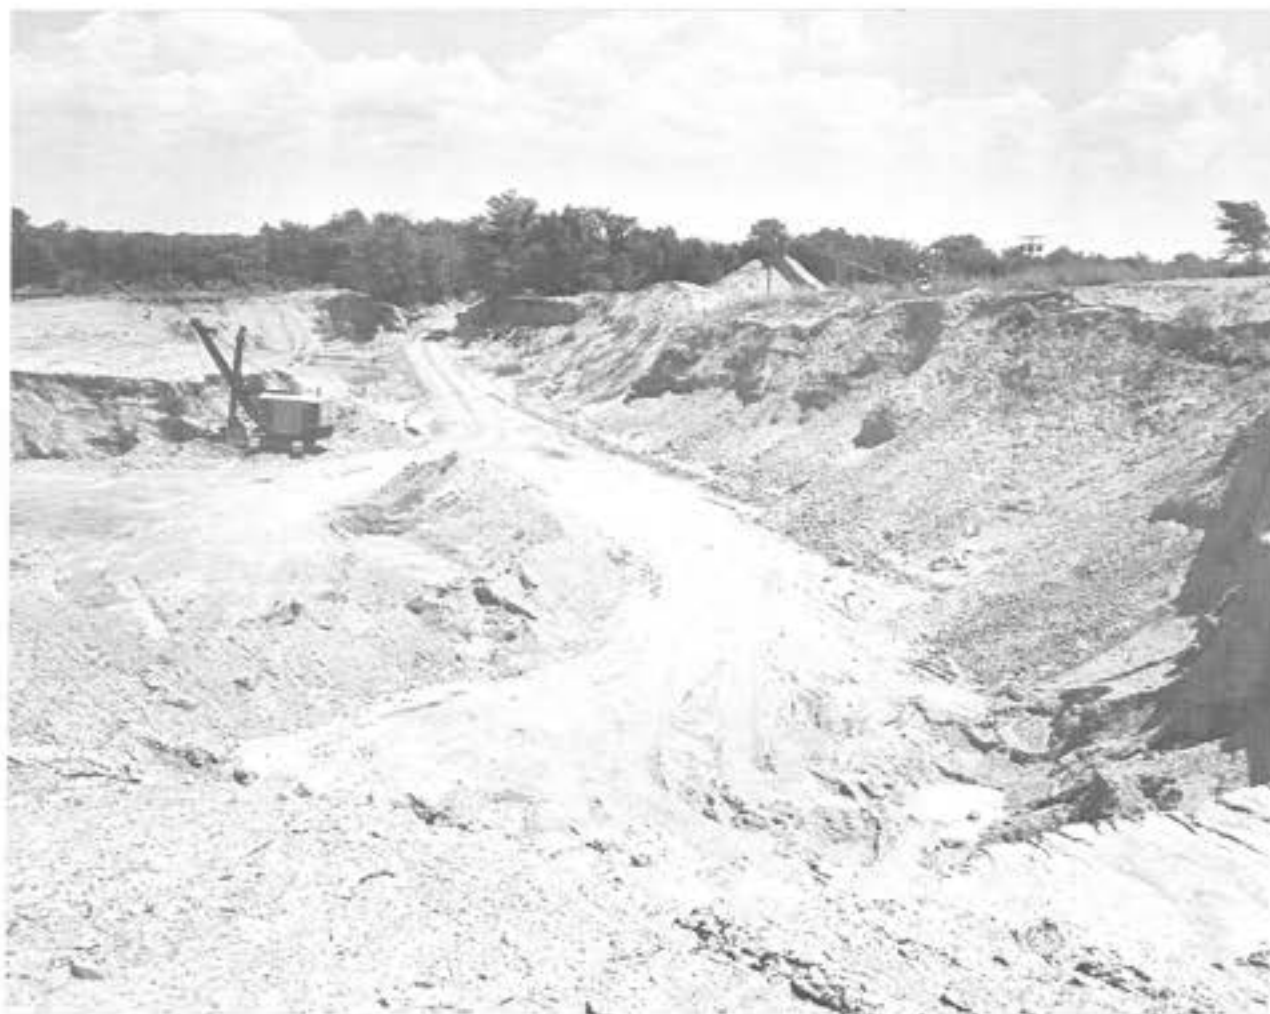
The sands and gravels underlying the till north of Milton and Hornby apparently carry at least modest supplies of potable water.

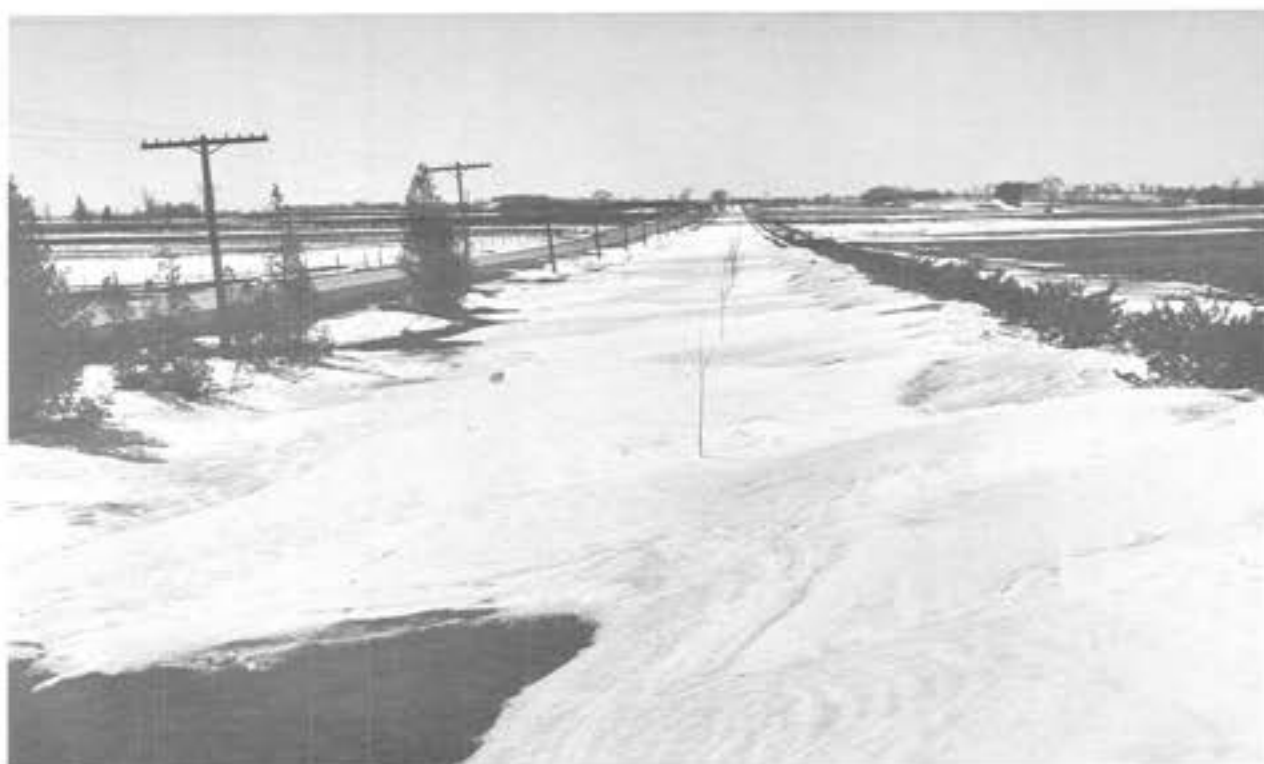
A well placed snow fence piles the snow where it will do no harm and leaves the road surface clear.

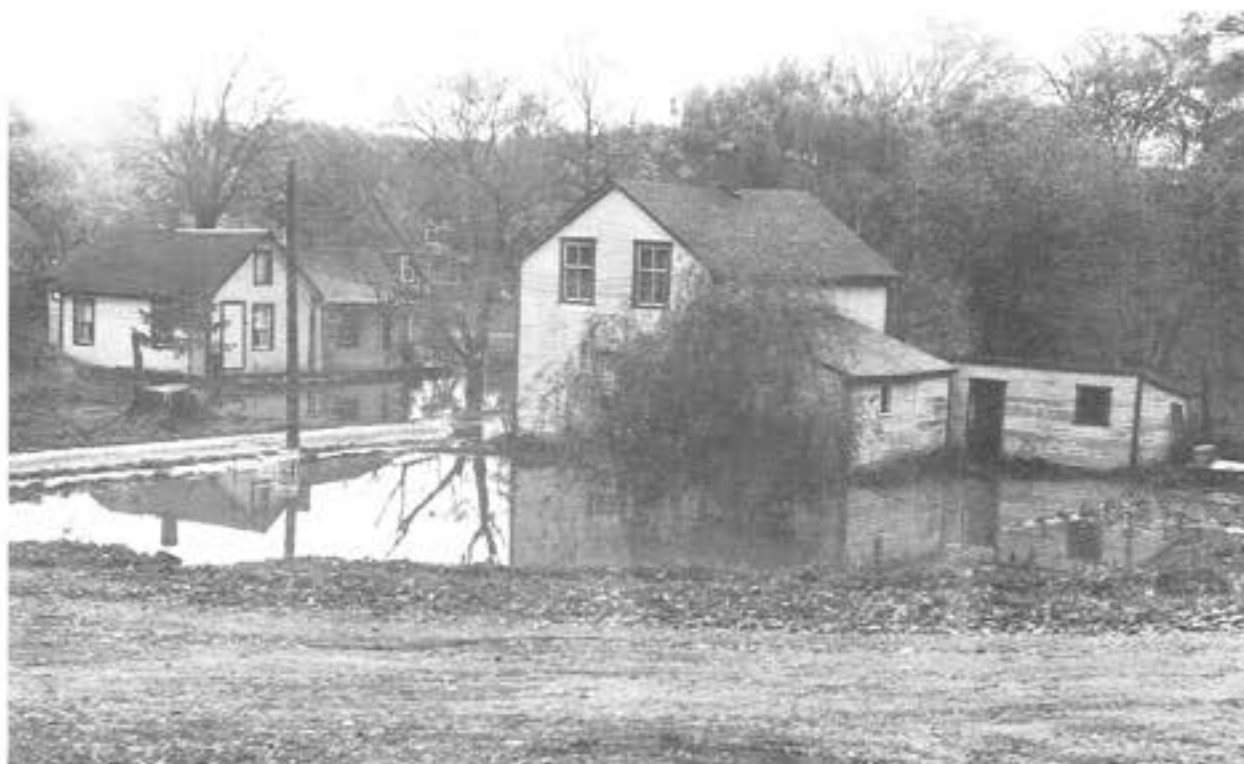
View looking south-east from corner of Charles and Pine Streets showing flooding caused by backwater from sewers.

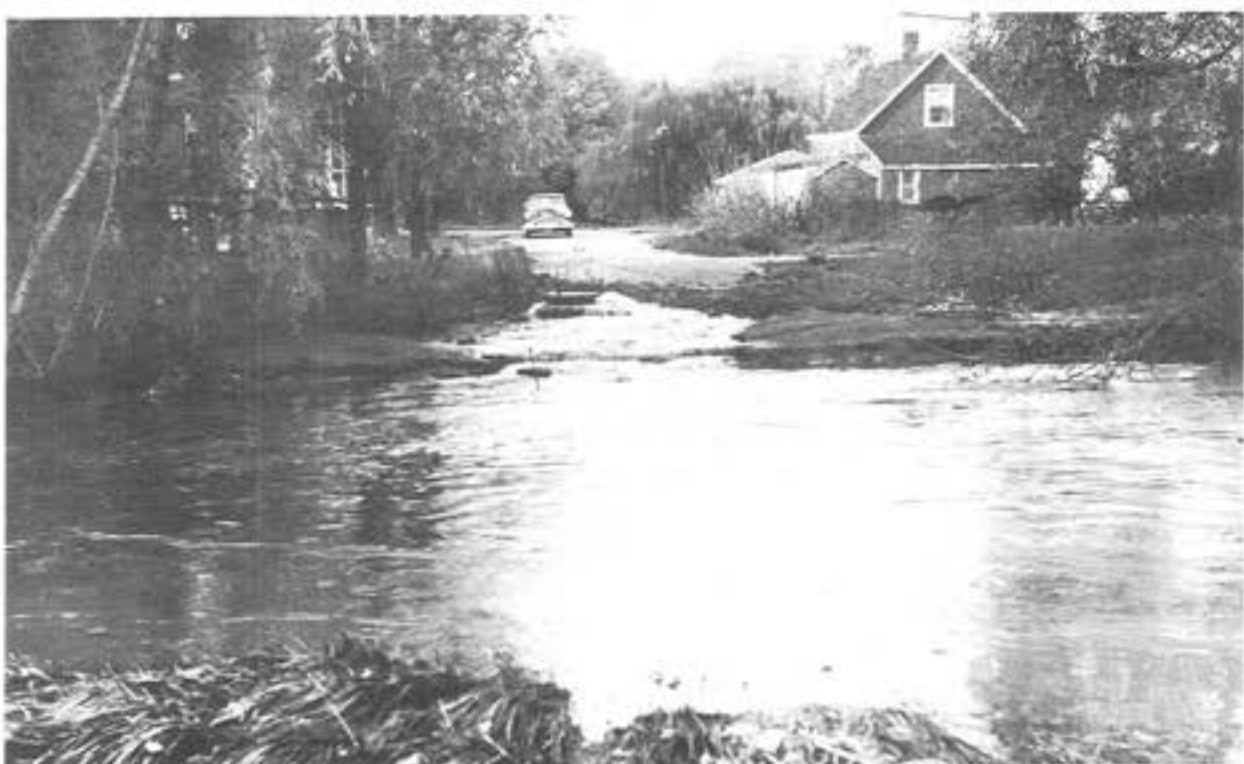
West Branch at Oak Street in Milton. This picture and the one above were taken the day after Hurricane Hazel.

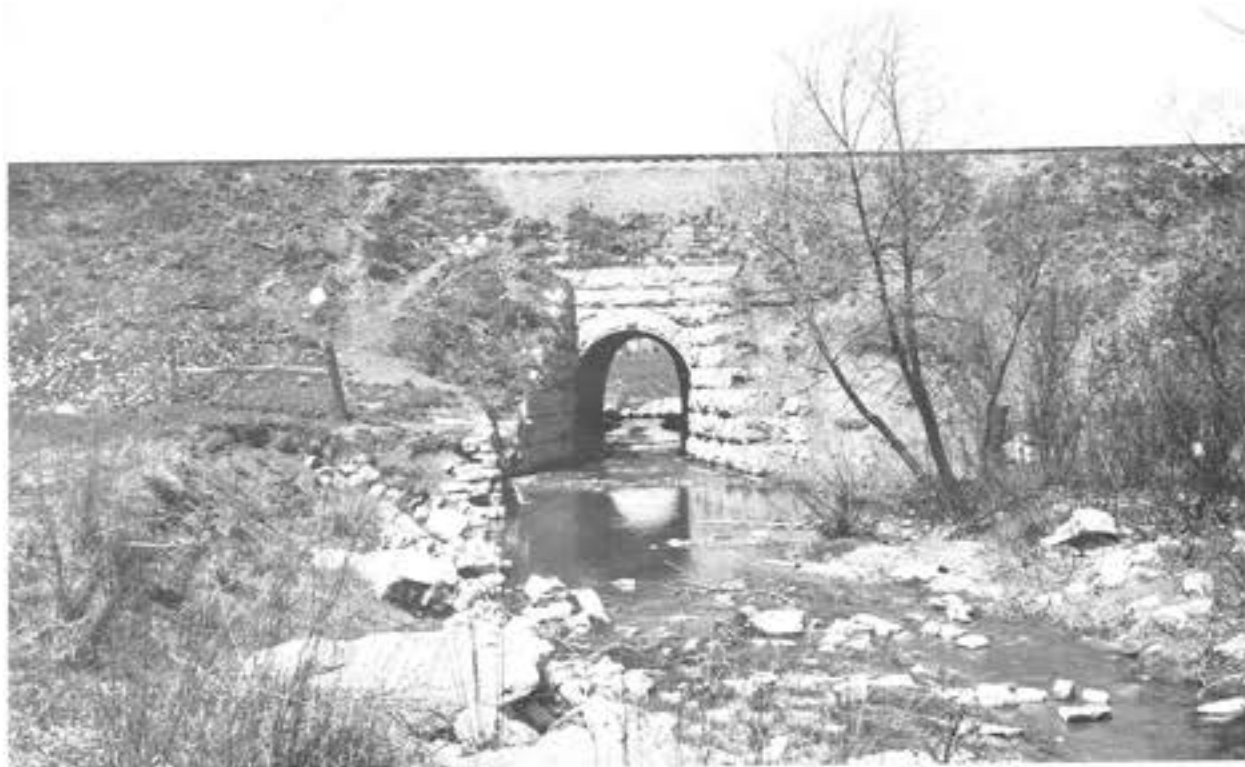
Looking upstream at the C. D. P. culvert on Tributary W.D. in Milton.

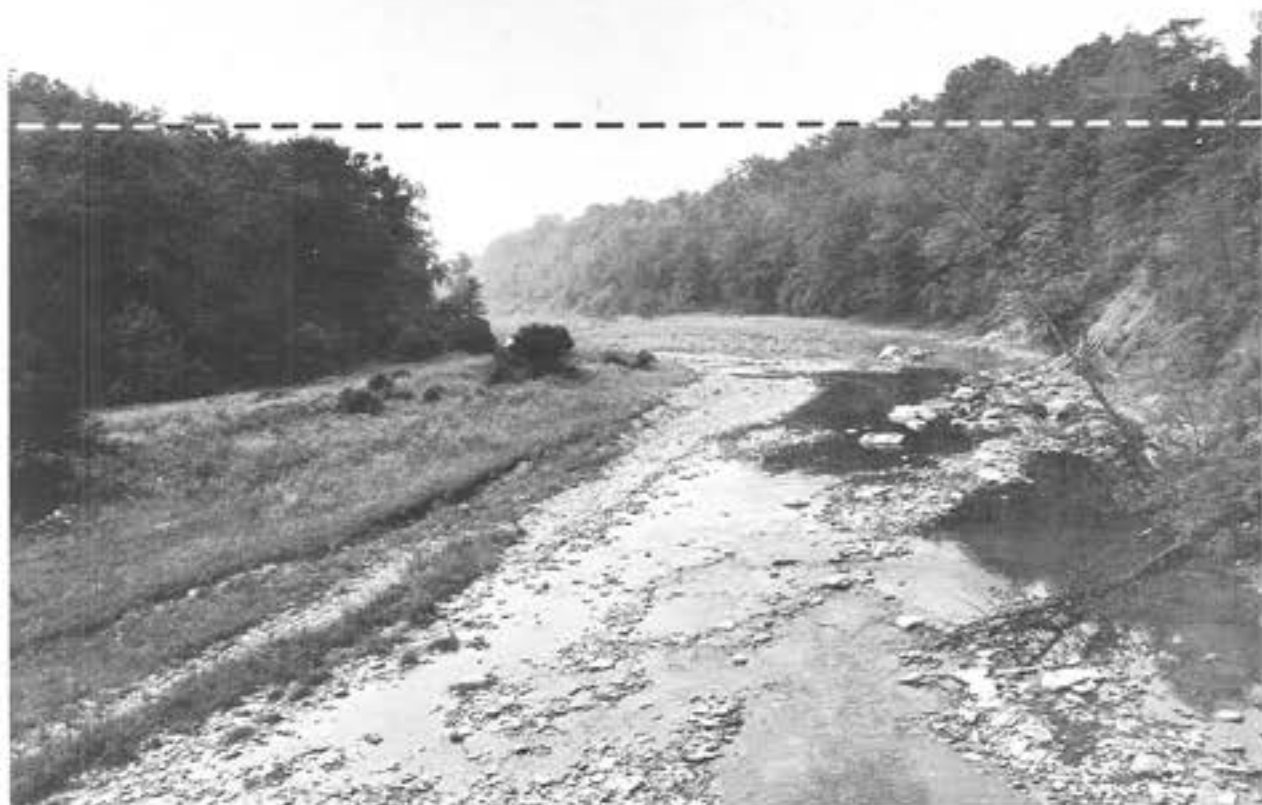
Looking downstream at the Glenorchy damsite from road crossing. Broken line indicates top of possible dam at this site.

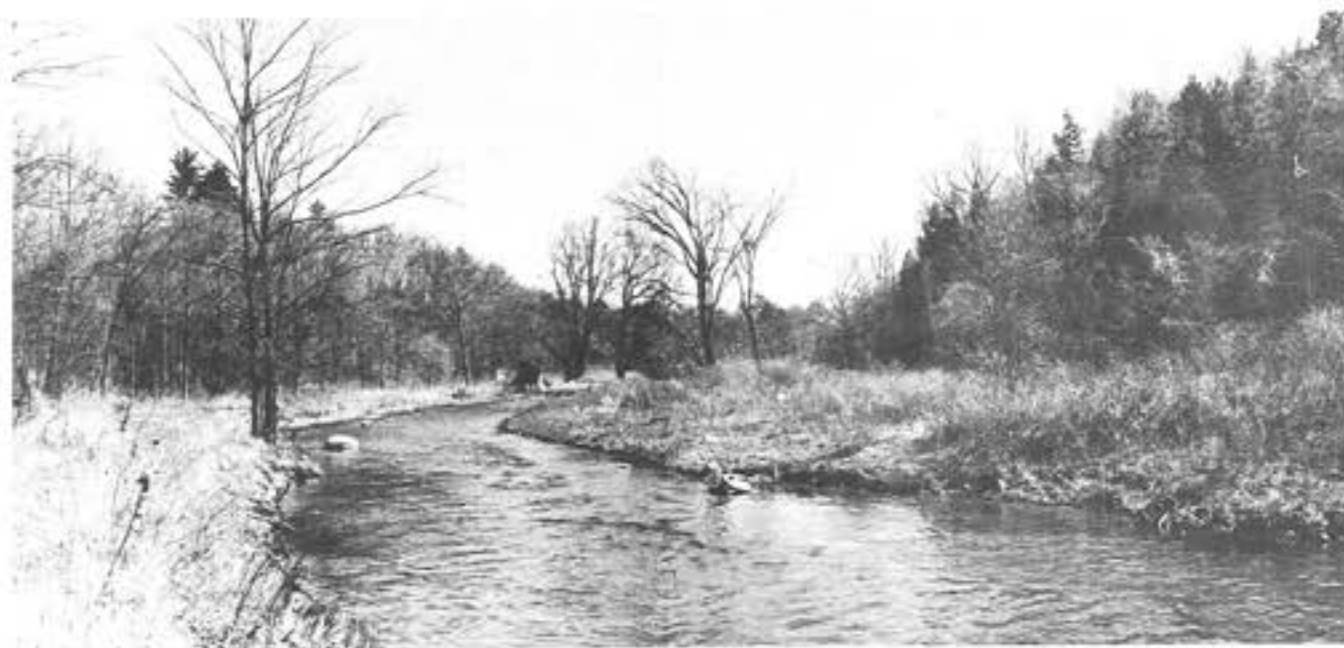
Panoramic view of the area which would be flooded if the Boyne dam were constructed.

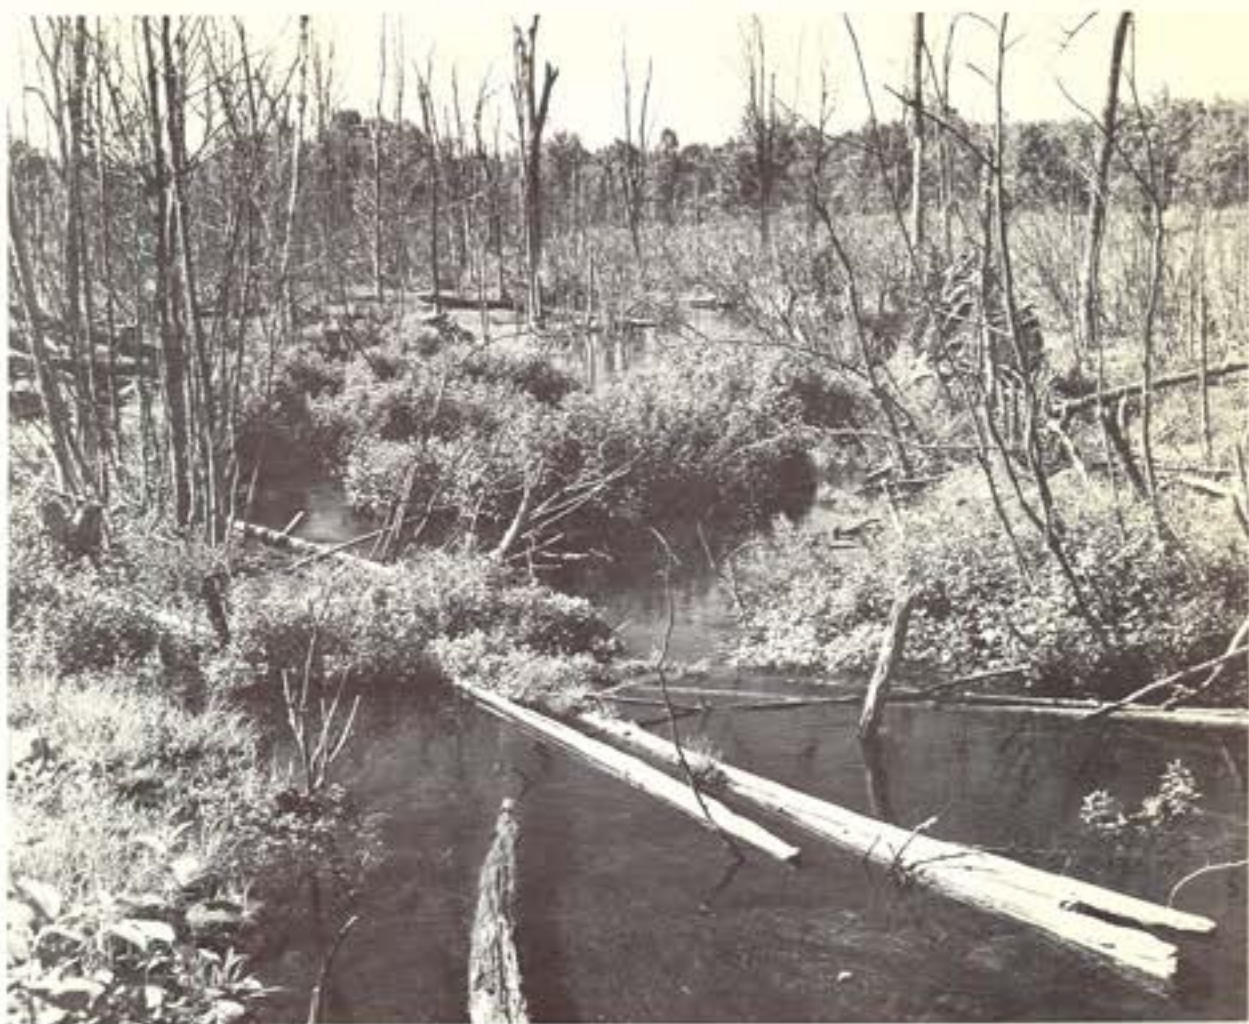
The effects of beaver dams on the appearance and vegetation of the watershed in Concession I of Nassagaweya Township. The beaver have since been removed by staff of the Department of Lands and Forests.

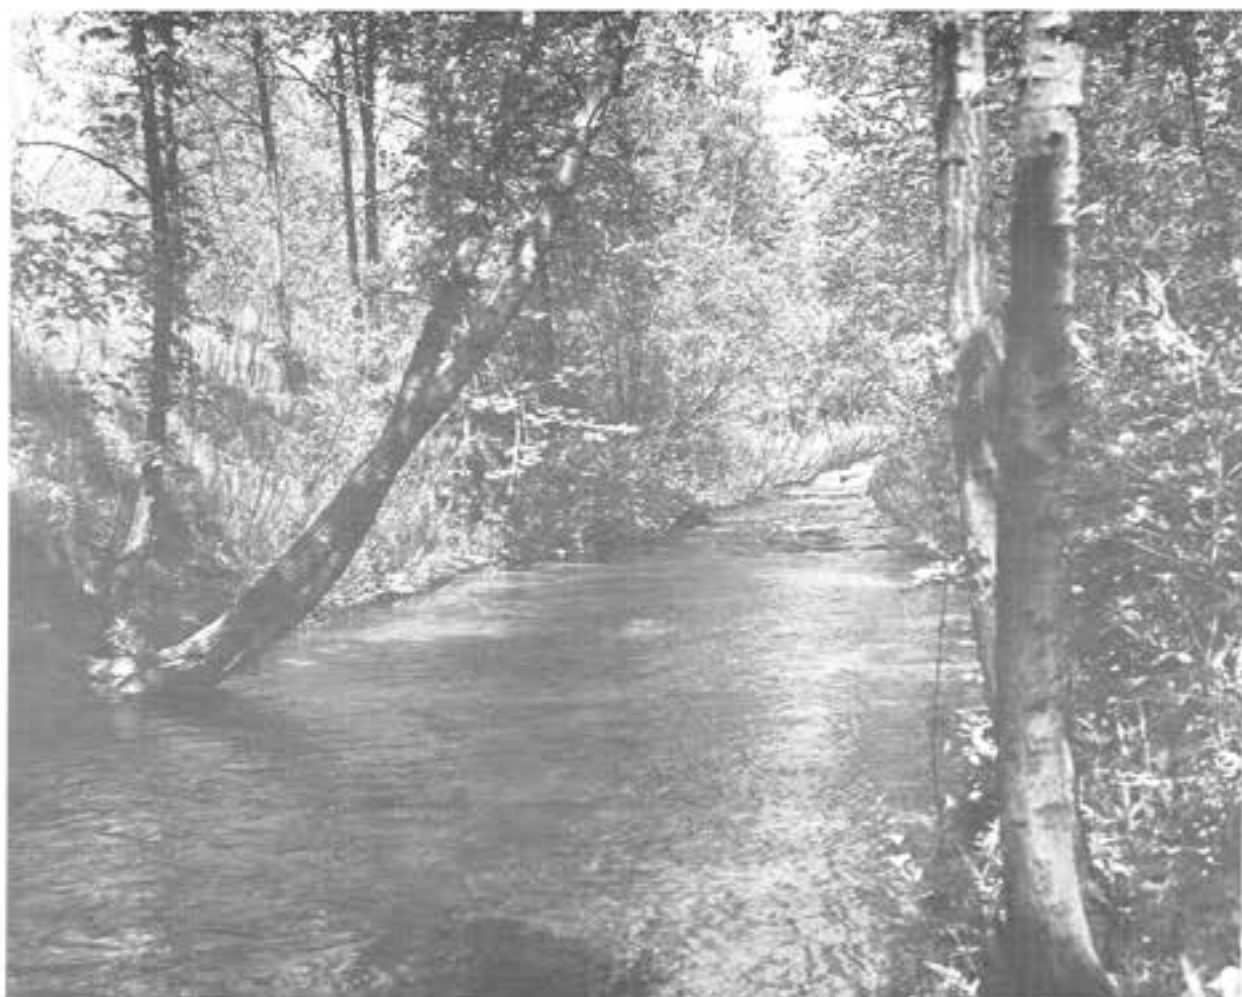
The typical condition of the west branch of Sixteen-Mile Creek in summer. The gradient is high, the stream relatively shallow, and there is a shortage of good fish cover. This stream is 2 miles southeast of Campbellville, not far from excellent spring sources.

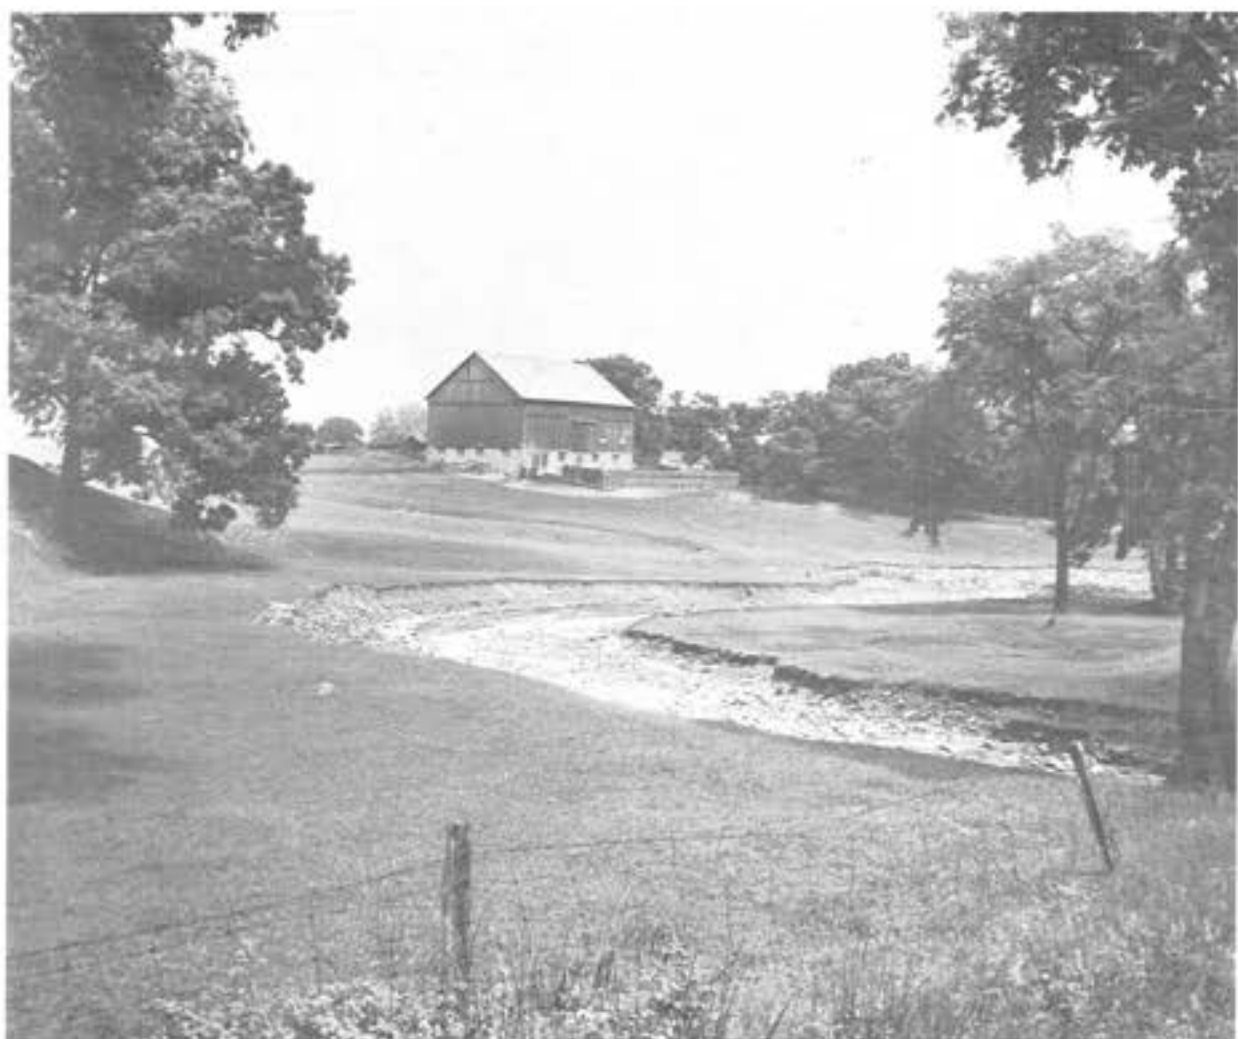
The typical summer condition of the upper parts of the Oakville Creek in the Peel Plain. The stream is dry but there are scattered standing pools. This photograph was taken in Concession 5 of Trafalgar Township.
