# Conservation Halton Watershed Report Card 2023

Conservation Halton has prepared this report card as a summary of the state of your forests and water resources.

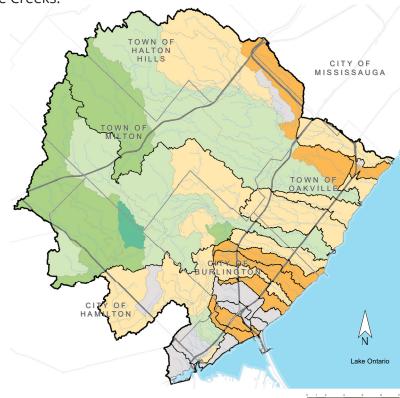
Grades for surface water quality are based on chemical (phosphorus concentrations) and biological (benthic invertebrates) indicators of water quality across the watershed.

- Grades ranged from A (Excellent) to F (Very Poor).
- Subwatersheds with lower scores (D to F) tend to be in agricultural or urban areas.
- Subwatersheds with higher scores (A to C) tend to be in areas with more natural cover, including higher amounts of forest cover.
- Ongoing efforts to improve stormwater management and increase the use of low impact development (LID) practices will help to improve water quality.
- 9 subwatersheds saw improvements, receiving a higher grade than they had scored in the 2018 Watershed Report Card.
- 9 subwatersheds had more degraded conditions, receiving a lower grade than in 2018.
- 6 out of the 11 water chemistry stations sampled over the last 5 years had chloride concentrations above the water quality objective. These stations were within Sheldon, Fourteen Mile and Sixteen Mile Creeks.

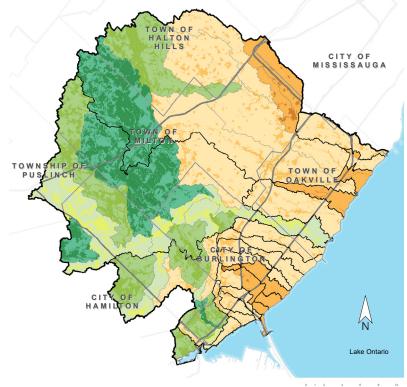
### **FOREST**

Grades are based on the percentage of forest cover, interior forest cover (forest cover 100m from the forest edge) and streamside vegetation that is forested. Streamside forests in particular help improve water quality.

- Grades ranged from A (Excellent) to F (Very Poor).
- Majority of forest cover and forest interior was found above the Niagara Escarpment where urban development and agricultural activities are limited.
- Large tracts of forests are scarce and found largely in the headwaters of Bronte and Sixteen Mile Creek. Most interior forest habitat is found in these areas.
- Forest patches in urban areas are small with many associated with stream valleys.
- While coverage of streamside vegetation is good in some areas, increases in vegetation along streams will aid in improving water quality and the health of aquatic and terrestrial ecosystems.

$\bullet\,$  -7 subwatersheds received a lower grade than the 2018 report card, with 1 subwatershed

receiving a higher grade.

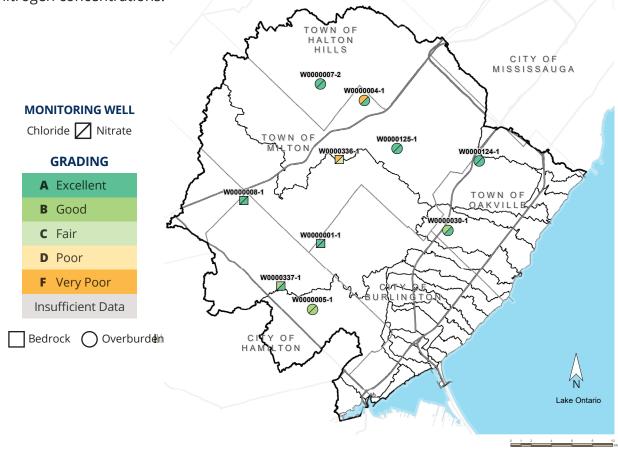
# Conservation Halton GROUNDWATER QUALITY

Grades for groundwater quality are based on concentrations of nitrate + nitrite and chloride levels at 10 groundwater wells across the Conservation Halton watershed. Wells have been monitored for the past 21 years

- Grades ranged from A (Excellent) to F (Very Poor) with mostly A grades, which represent the groundwater conditions at the well locations only.
- Groundwater quality can vary significantly from site to site and be influenced by geology, land use, human activities, etc.
- Two wells (W004-1 and W030-1) exhibit naturally higher chloride concentrations due to proximity to shale bedrock.

• Two wells (W336-1 and W005-1) are showing impacts from human activities such as road salting and agricultural activities as they are higher in both chloride and nitrogen concentrations.
